2020

Annual Inspection Report

Appendix 3: SR 408

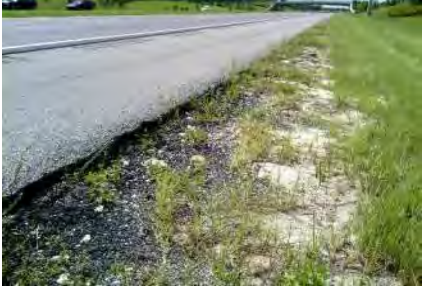
Roadway	Erosion	2	by paved shoulder	32
R90

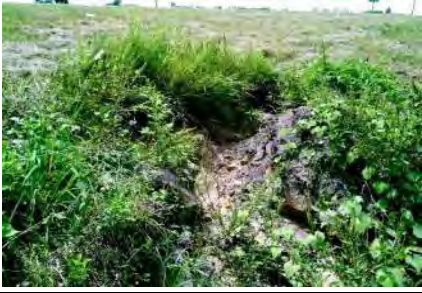
Roadway	Erosion	2	slope erosion	31
R91

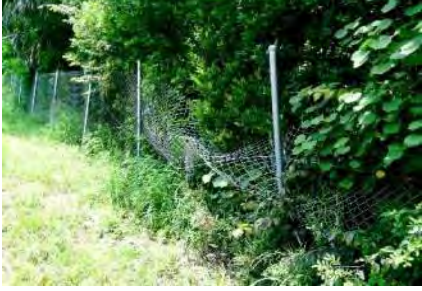
Roadway	Fence	2	fence damaged	29
R92

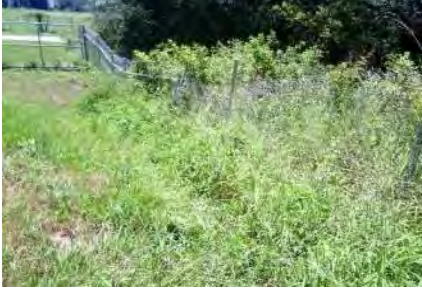
Roadway	Fence	2	damaged	28

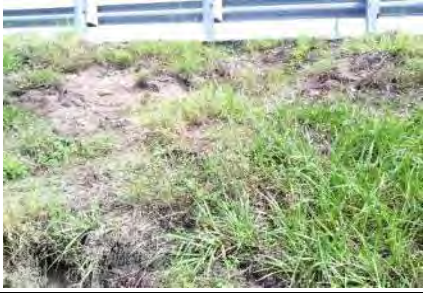
Roadway	Erosion	2	slope shoulder along the complete section behind the guard rail	22
R95

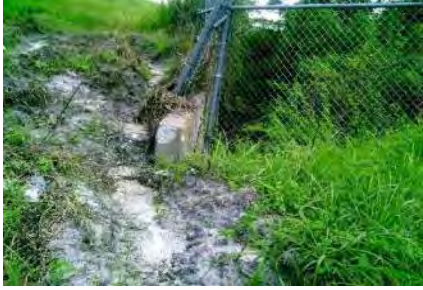
Roadway	Fence	2	fence and erosion	17
R96

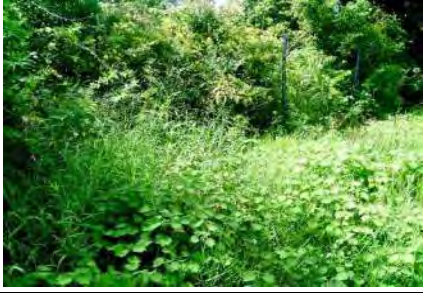
Roadway	Fence	2	damaged	15
R97

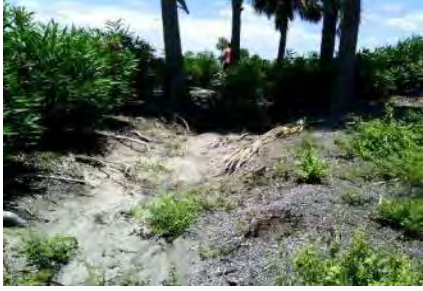
Roadway	Erosion	3	erosion	2
R98

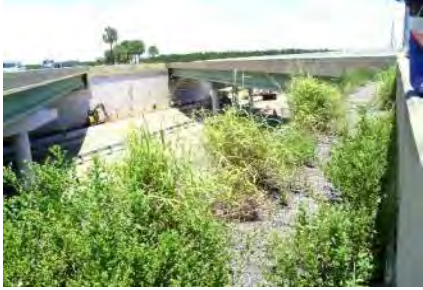
Roadway	Other	3	veg on top of bridge	2

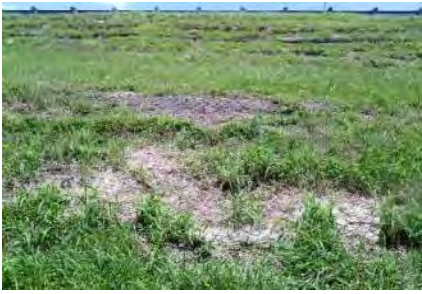
Roadway	Erosion	3	bank erosion toe of slope	2
R100

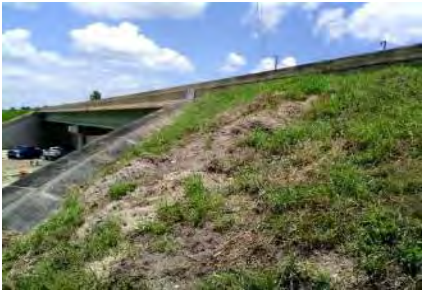
Roadway	Erosion	3	slope erosion	2
R101

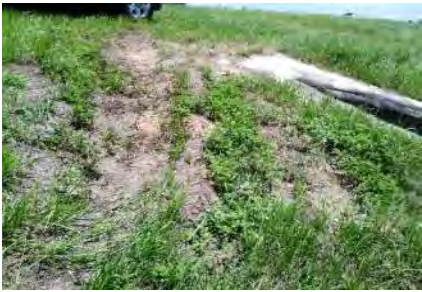
Roadway	Erosion	3	mes patch / undermine flume	1
R102

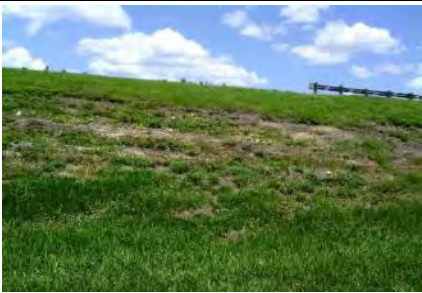
Roadway	Erosion	3	slope erosion	1
R103

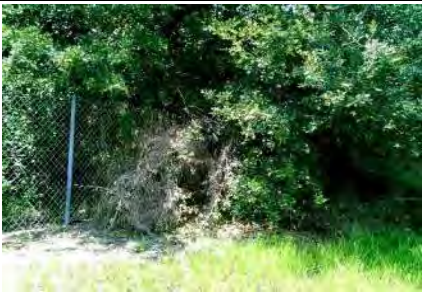
Roadway	Fence	3	tree over fence	1
R104

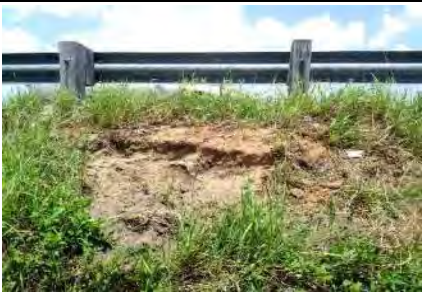
Roadway	Erosion	3	erosion approaching road shoulder	1

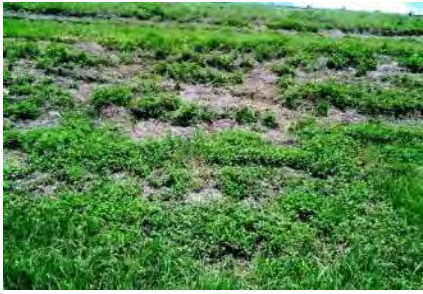
Roadway	Erosion	3	erosion	1
R106

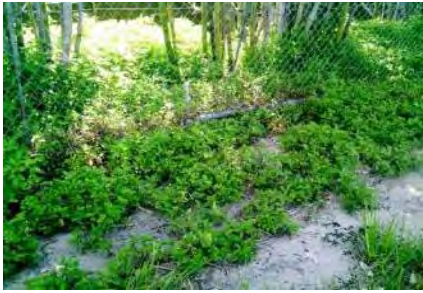
Roadway	Fence	3	damage posts	1
R107

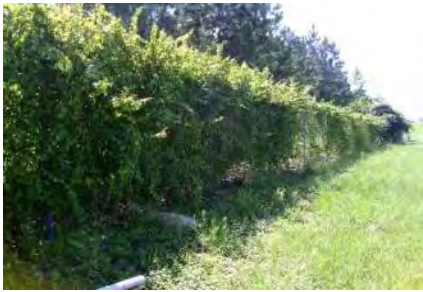
Roadway	Fence	3	veg on fence	3
R108

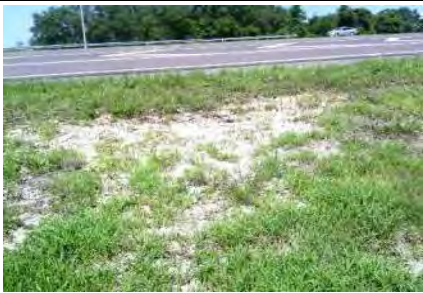
Roadway	Erosion	3	shoulder swale erosion	3
R109

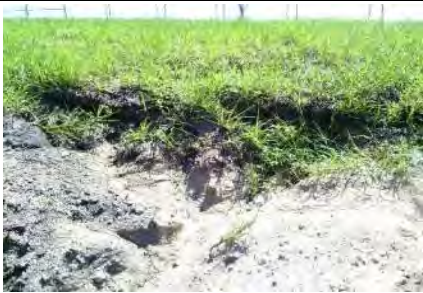
Roadway	Erosion	3	slope erosion	3
R110

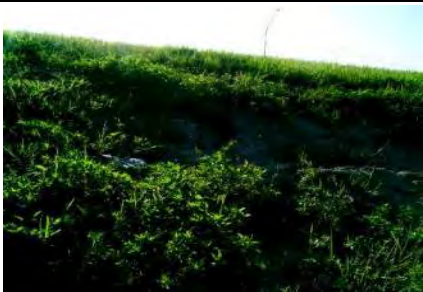
Roadway	Erosion	3	erosion	6

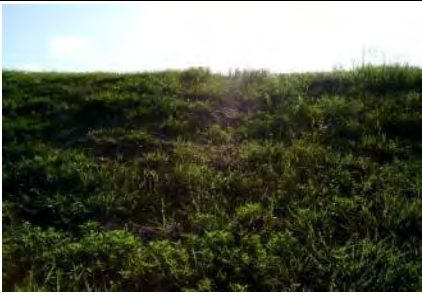
Roadway	Erosion	3	erosion	6
R112

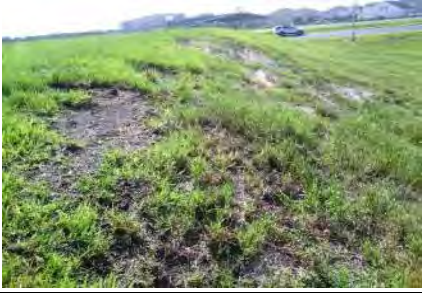
Roadway	Erosion	3	erosion	5
R113

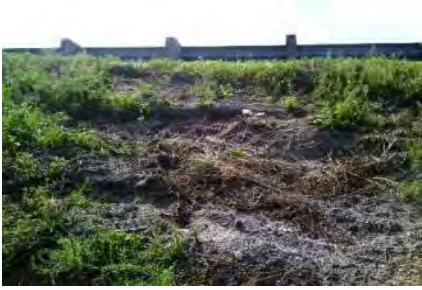
Roadway	Erosion	3	erosion	5
R114

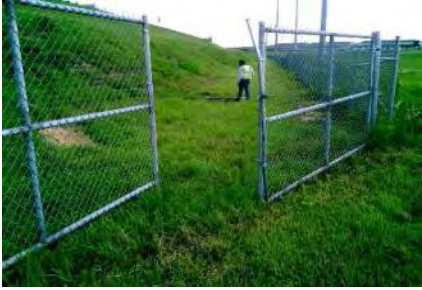
Roadway	Fence	3	missing lock	5
R115

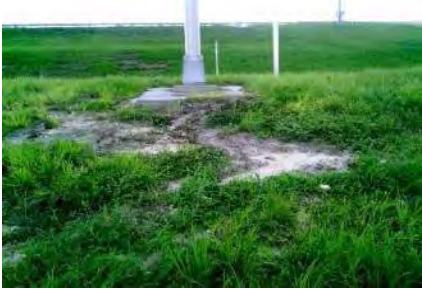
Roadway	Erosion	3	erosion	3
R116

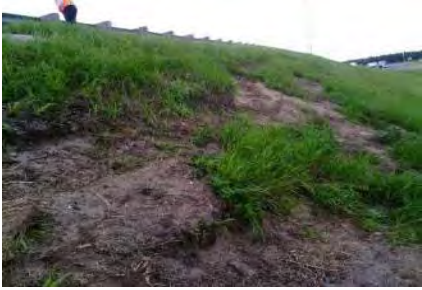
Roadway	Erosion	3	erosion	4

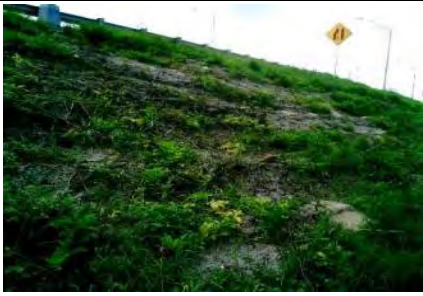
Roadway	Erosion	3	erosion	3
R118

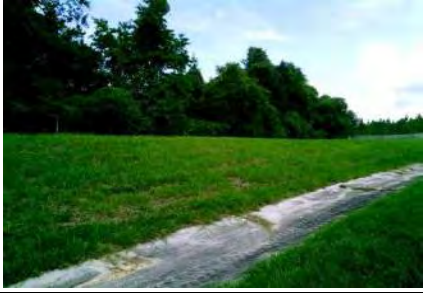
Roadway	Fence	3	vegetation	3
R119

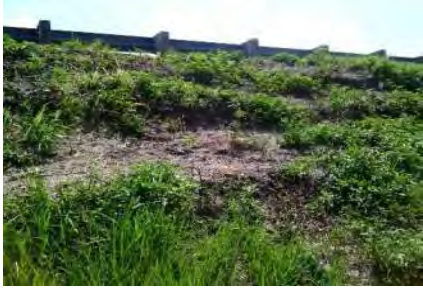
Roadway	Erosion	3	erosion	3
R120

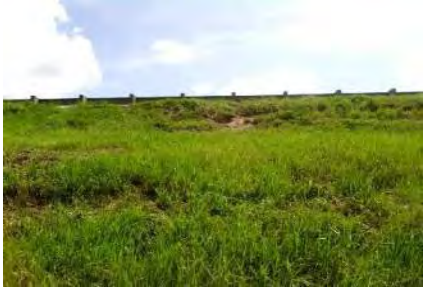
Roadway	Erosion	3	erosion	2
R121

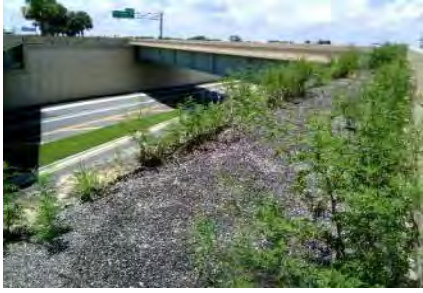
Roadway	Other	3	vegetation	5
R122

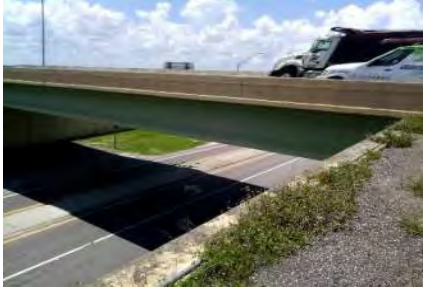
Roadway	Other	3	vegetation	3

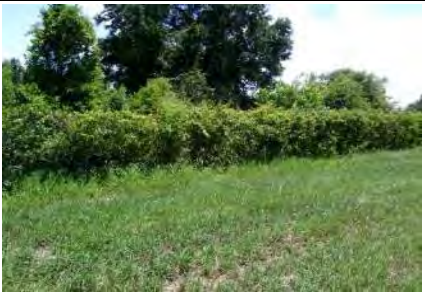
Roadway	Fence	3	vegetation	2
R124

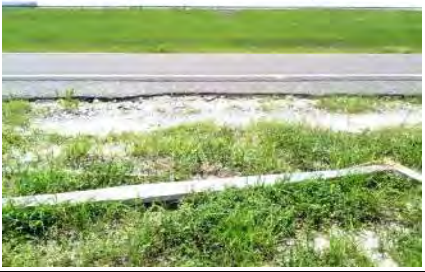
Roadway	Erosion	3	erosion	3
R125

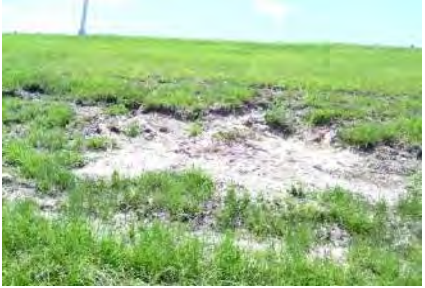
Roadway	Erosion	3	erosion	3
R126

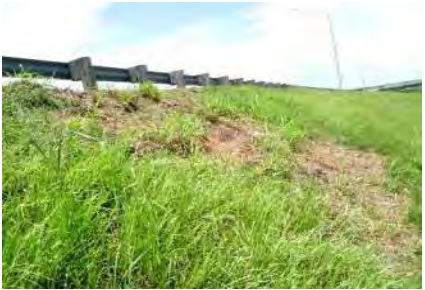
Roadway	Erosion	3	erosion	3
R127

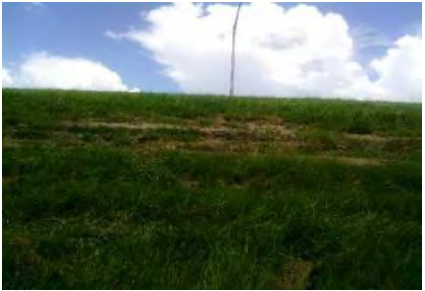
Roadway	Erosion	3	erosion	3
R128

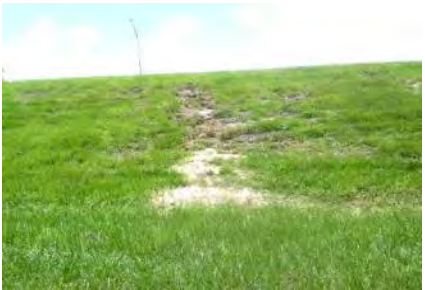
Roadway	Erosion	3	erosion	4

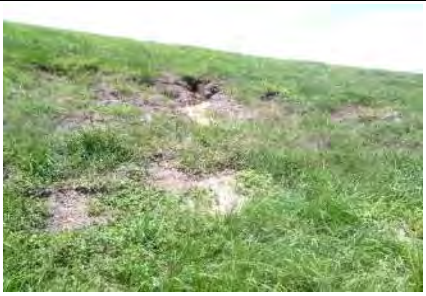
Roadway	Erosion	3	erosion/maintenance	4
R130

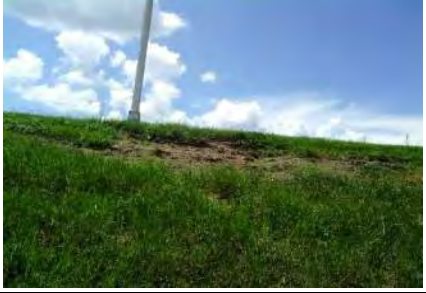
Roadway	Erosion	3	erosion	4
R131

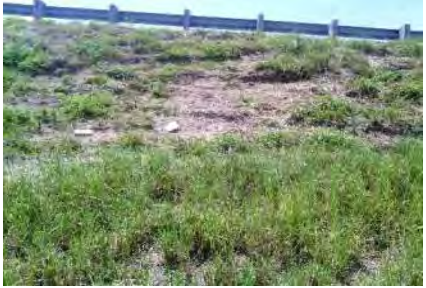
Roadway	Erosion	3	erosion	5
R132

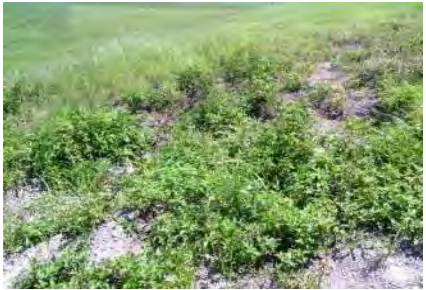
Roadway	Erosion	3	erosion	5
R133

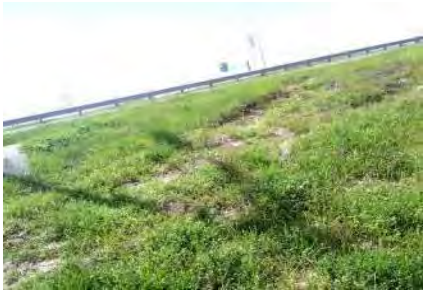
Roadway	Erosion	3	erosion	6
R134

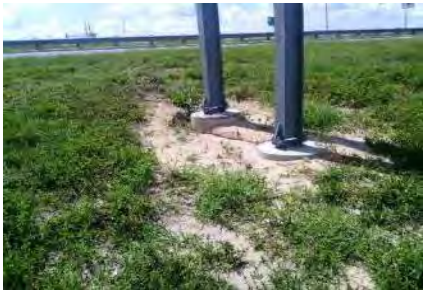
Roadway	Erosion	3	erosion at sign	6

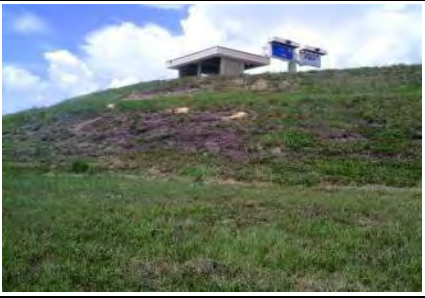
Roadway	Erosion	3	erosion	6
R136

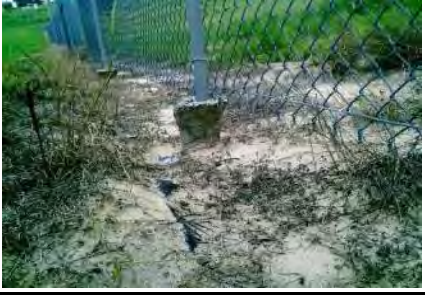
Roadway	Fence	3	uncovering fence post	8
R137

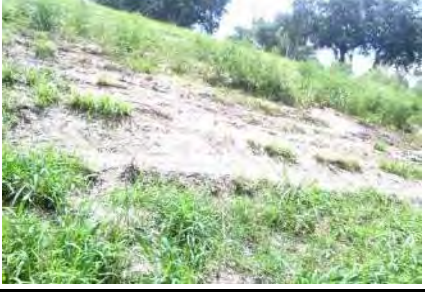
Roadway	Erosion	3	erosion	8
R138

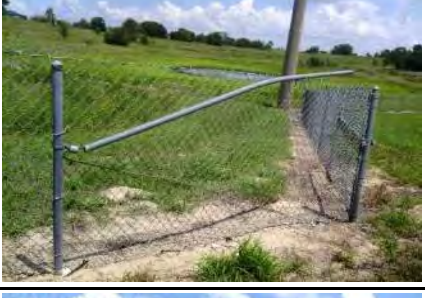
Roadway	Fence	3	fence post	8
R139

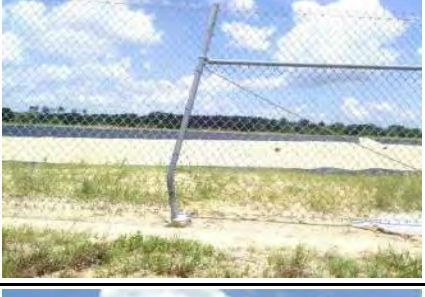
Roadway	Fence	3	fence post	8
R140

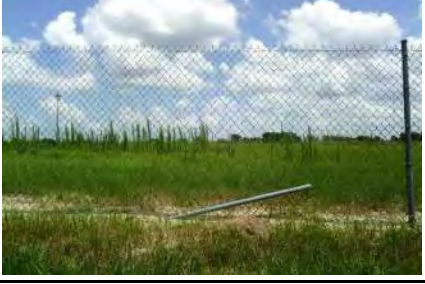
Roadway	Fence	3	fence post	6

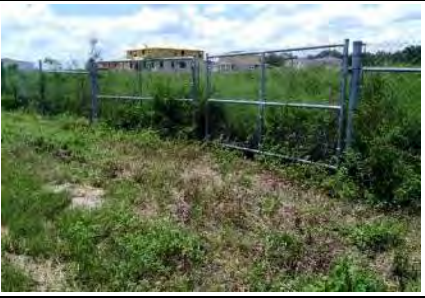
Roadway	Fence	3	vegetation and no lock	6
R142

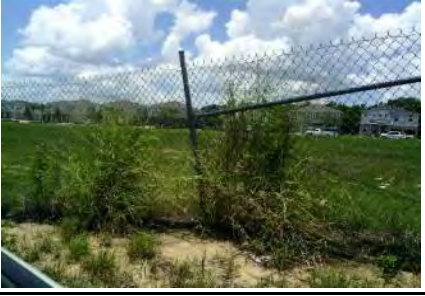
Roadway	Fence	3	post	6
R143

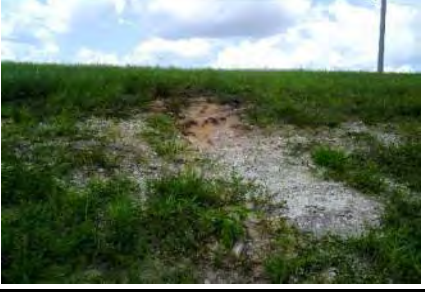
Roadway	Erosion	3	erosion	6
R144

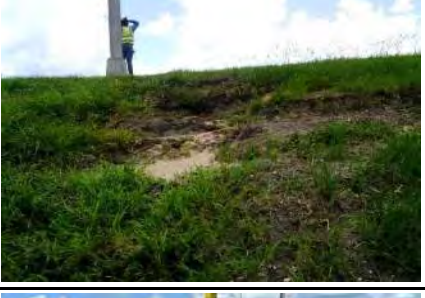
Roadway	Erosion	3	erosion	6
R145

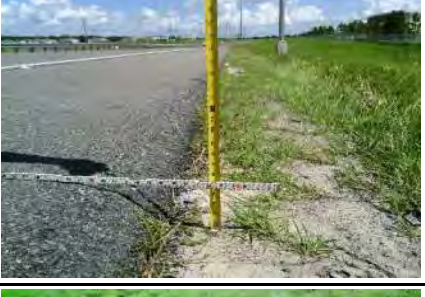
Roadway	Other	3	shoulder dropoff 5 inch	6
R146

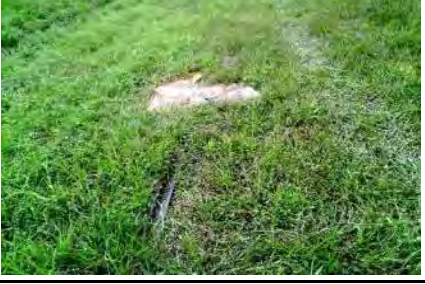
Roadway	Other	3	old sign not removed	6

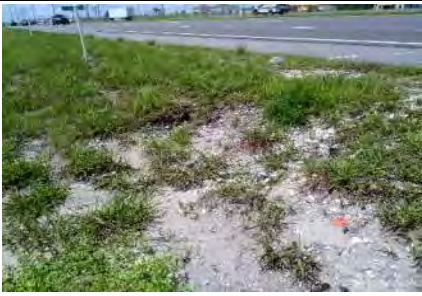
Roadway	Erosion	3	erosion by the shoulder	6
R148

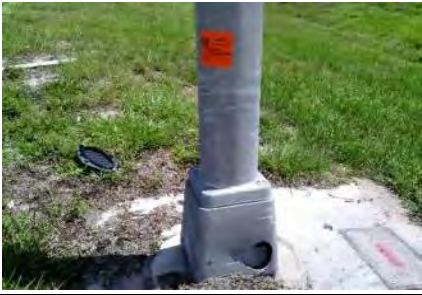
Roadway	Lighting	3	light pole damaged	6
R149

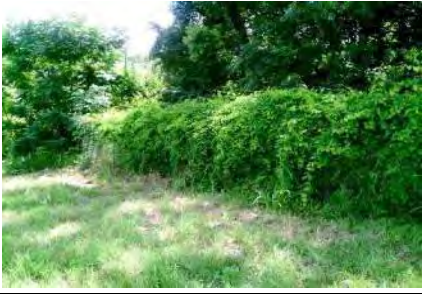
Roadway	Fence	3	overgrown fence	7
R150

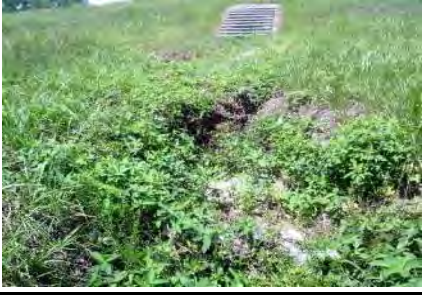
Roadway	Erosion	3	erosion 26 inch	7
R151

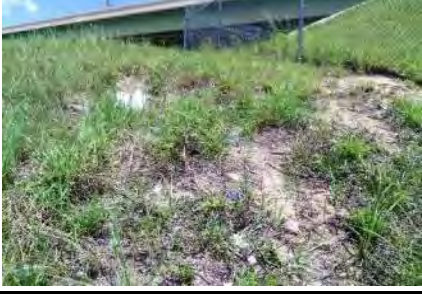
Roadway	Erosion	3	erosion	7
R152

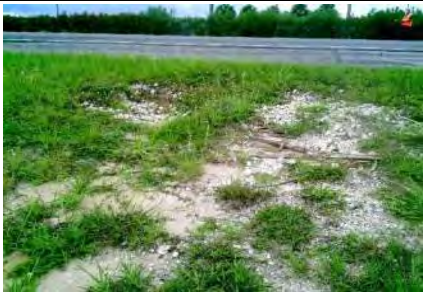
Roadway	Erosion	3	erosion by the shoulder	9
R154

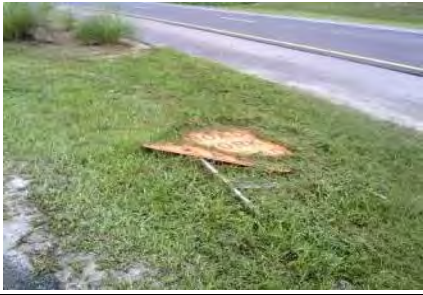
Roadway	Other	3	temporary sign not removed	8
R155

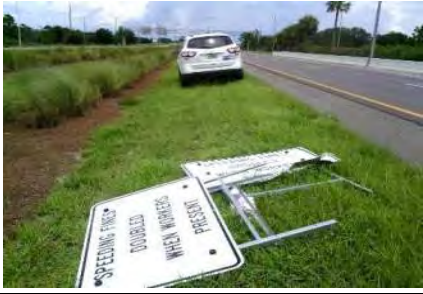
Roadway	Other	3	temporary sign not removed	9
R156

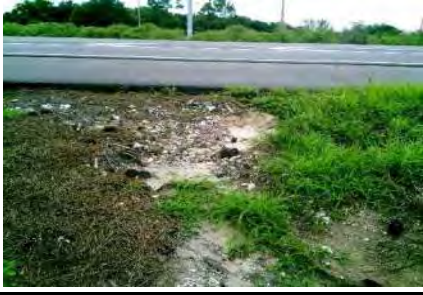
Roadway	Erosion	3	erosion by the shoulder	9
R157

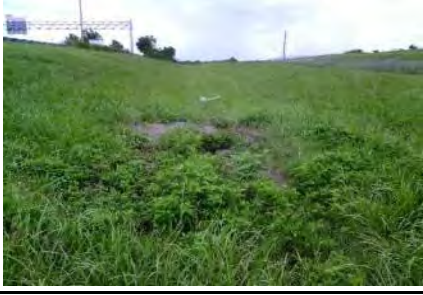
Roadway	Erosion	3	ditch needs regrading	9
R158

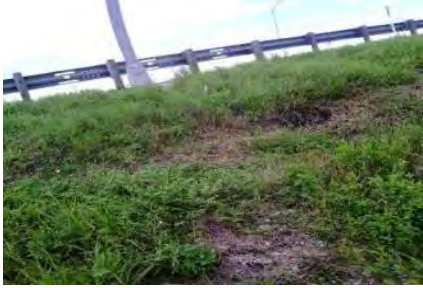
Roadway	Erosion	3	slope erosion	9

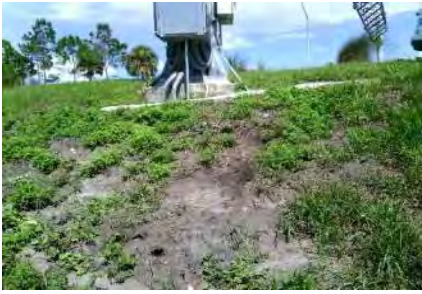
Roadway	Erosion	3	erosion behind the sign structure	9
R160

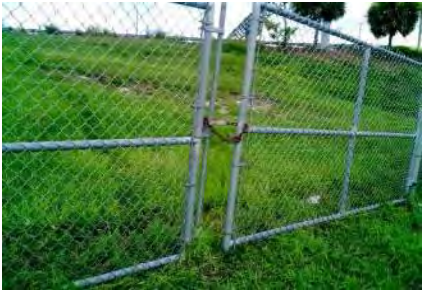
Roadway	Fence	3	broken lock and tilted gate	9
R161

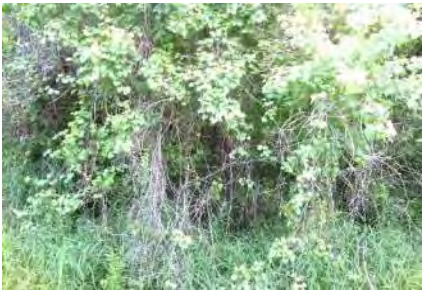
Roadway	Fence	3	vegetation overgrown	9
R162

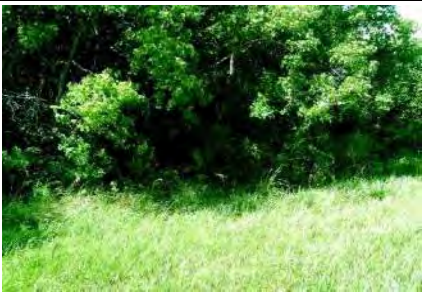
Roadway	Fence	3	vegetation overgrown	9
R163

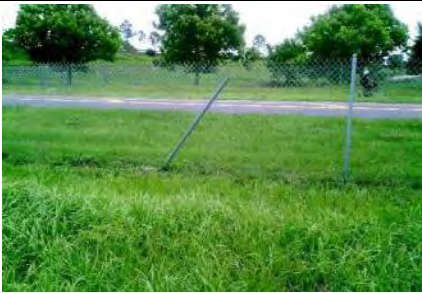
Roadway	Fence	3	post x2	10
R164

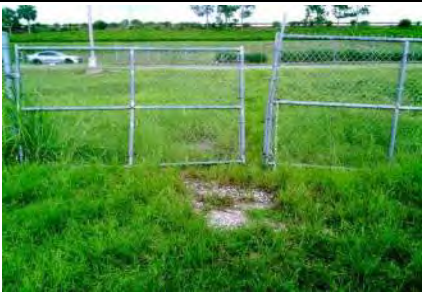
Roadway	Fence	3	fence gate damaged	12

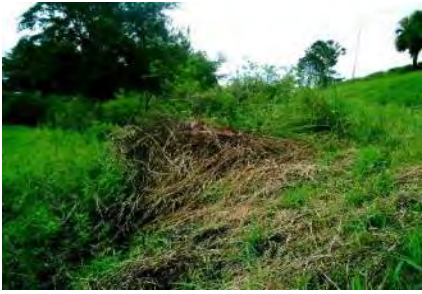
Roadway	Other	3	overgrown vegetation on the embankment	12
R166

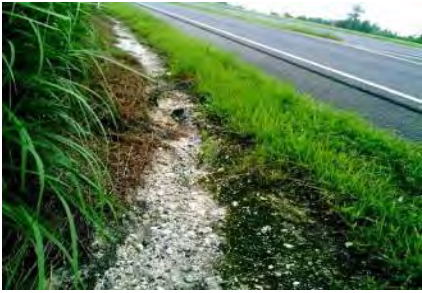
Roadway	Erosion	3	roadside erosion	11
R167

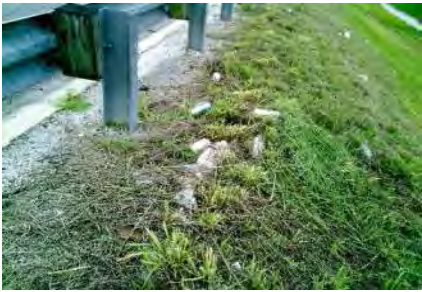
Roadway	Other	3	debris	16
R168

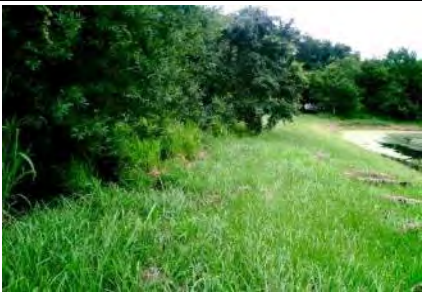
Roadway	Fence	3	vegetation overgrown	15
R169

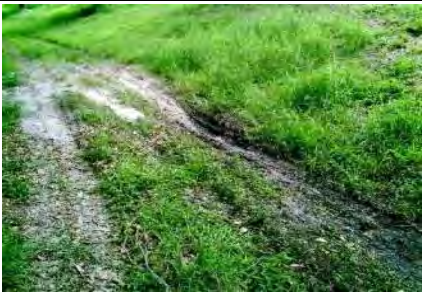
Roadway	Erosion	3	ditch regrading	15
R170

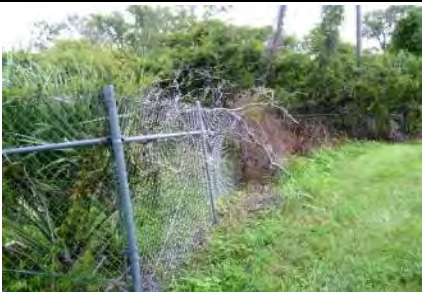
Roadway	Fence	3	excessive vegetation on fence line / damaged fence line	13

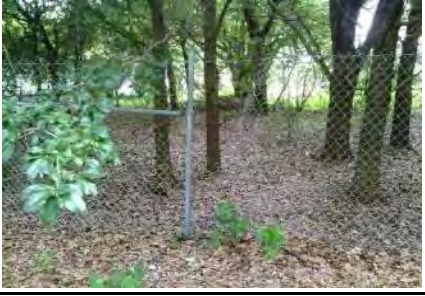
Roadway	Fence	3	gap open	14
R173

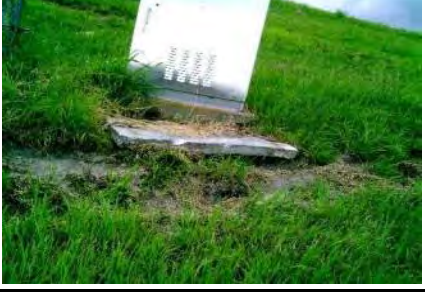
Roadway	Erosion	3	load center	13
R174

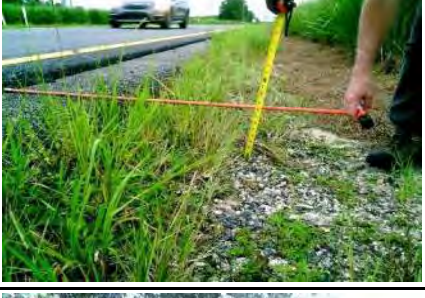
Roadway	Erosion	3	8in dropoff	11
R175

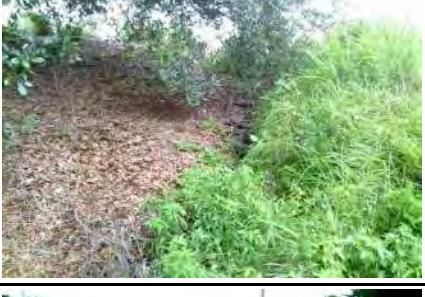
Roadway	Erosion	3	washout	13
R176

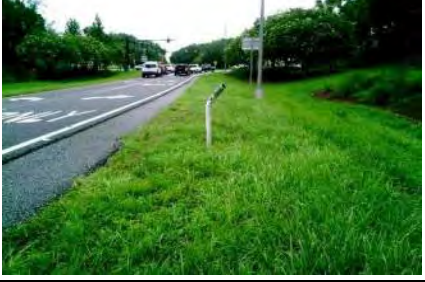
Roadway	Other	3	delineator damaged	16

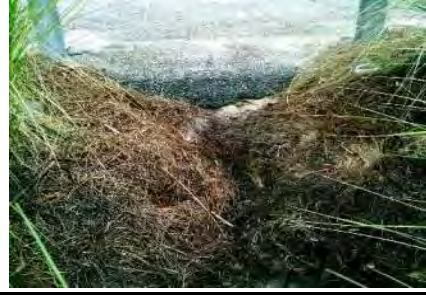
Roadway	Erosion	3	erosion	15
R179

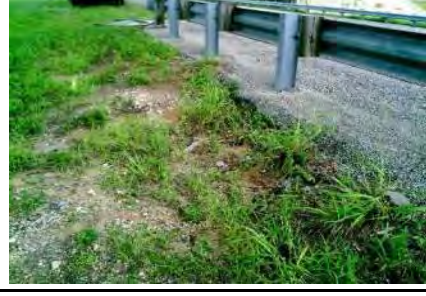
Roadway	Erosion	3	erosion behind the guard rail	16
R180

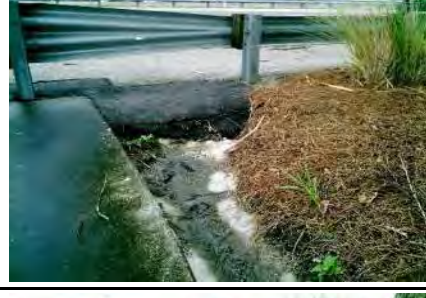
Roadway	Erosion	3	erosion behind the guard rail	17
R181

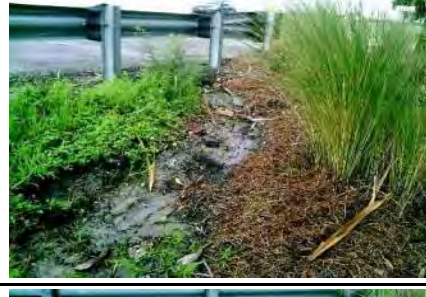
Roadway	Erosion	3	erosion behind the guard rail	17
R182

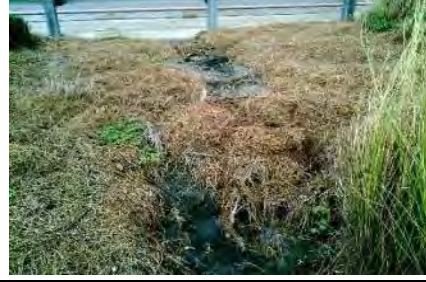
Roadway	Erosion	3	erosion behind the guard rail	17

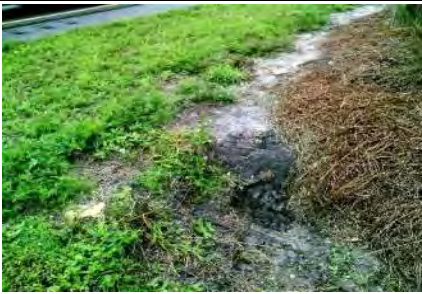
Roadway	Erosion	3	erosion	23
R184

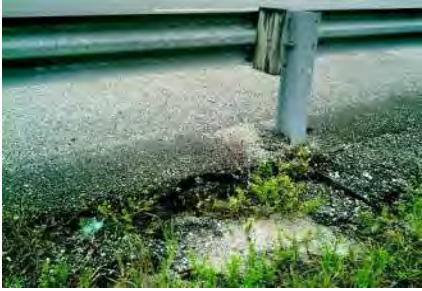
Roadway	Erosion	3	erosion behind the guard rail	23
R185

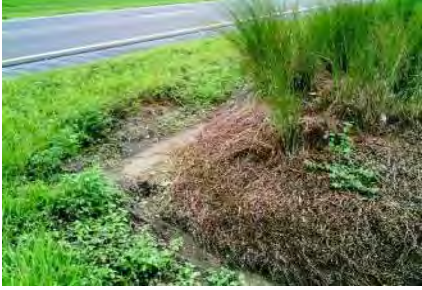
Roadway	Erosion	3	erosion	24
R186

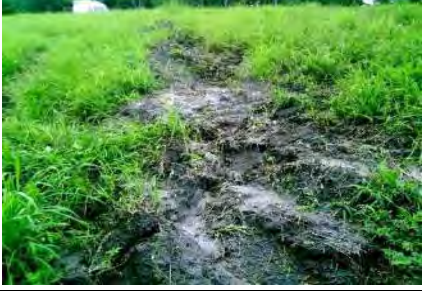
Roadway	Erosion	3	slope erosion	16
R187

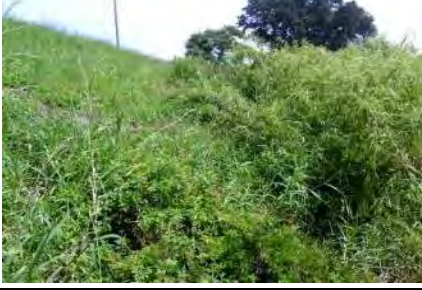
Roadway	Other	3	overgrown vegetation	17
R188

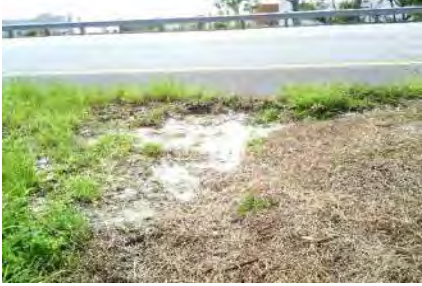
Roadway	Erosion	3	erosion by the shoulder	18

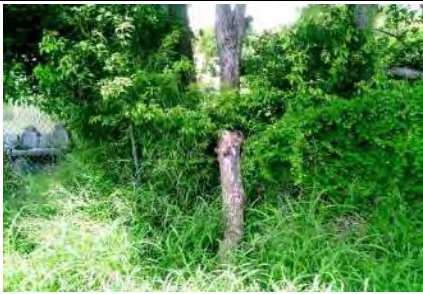
Roadway	Fence	3	overgrown vegetation on fence	18
R190

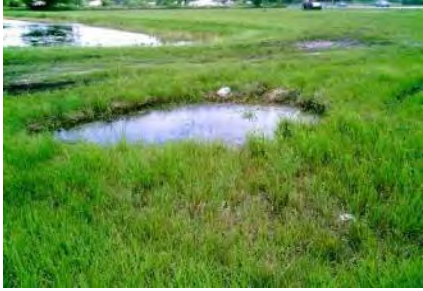
Roadway	Other	3	regrade swale	18
R191

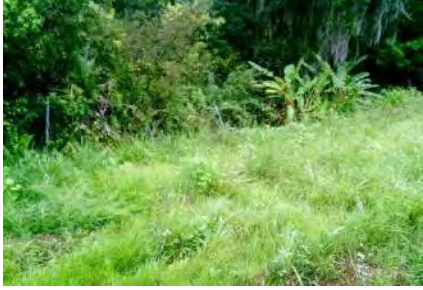
Roadway	Fence	3	vegetation overgrown /fence damaged	20
R192

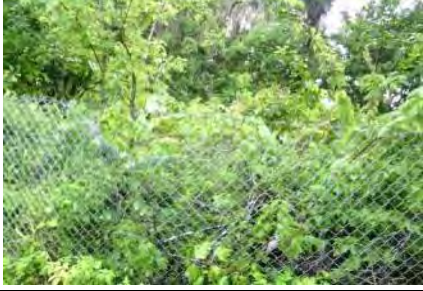
Roadway	Fence	3	fence damaged	20
R193

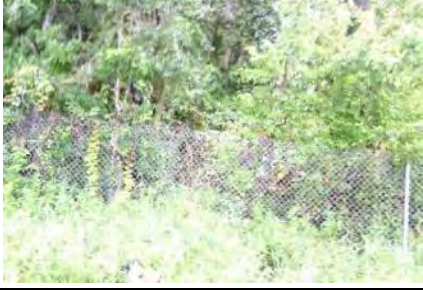
Roadway	Fence	3	fence post missing	20
R194

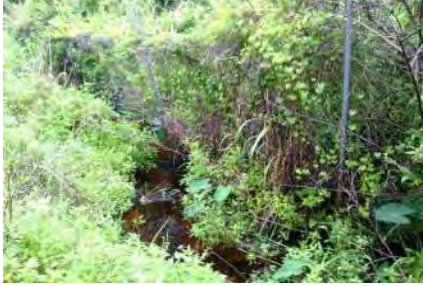
Roadway	Fence	3	fence damaged / vegetation overgrown	20

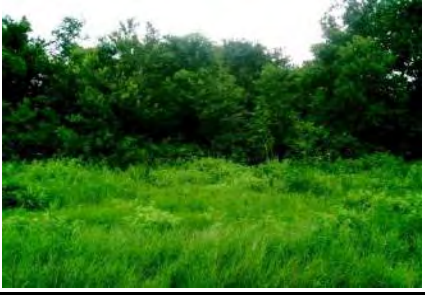
Roadway	Fence	3	fence damaged	21
R197

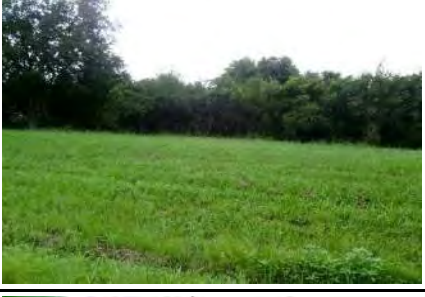
Roadway	Fence	3	vegetation overgrown	21
R198

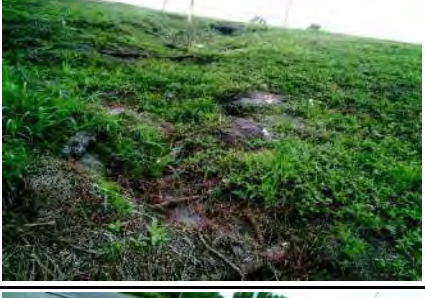
Roadway	Erosion	3	erosion	23
R199

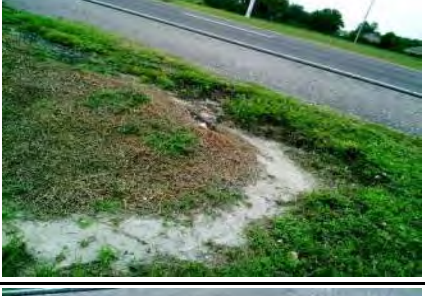
Roadway	Erosion	3	erosion	23
R200

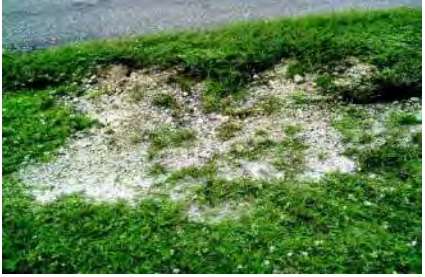
Roadway	Erosion	3	erosion	23

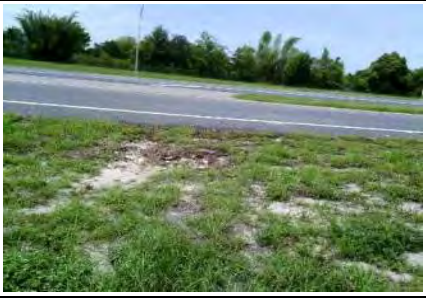
Roadway	Erosion	3	erosion	24
R202

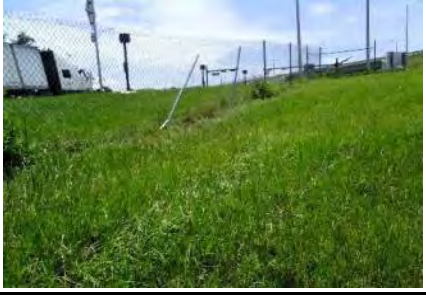
Roadway	Fence	3	fence post damaged	25
R203

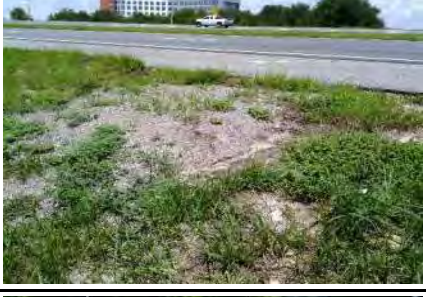
Roadway	Erosion	3	erosion	26
R204

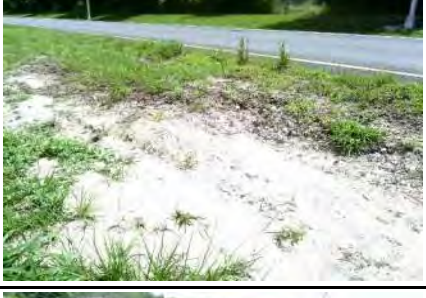
Roadway	Erosion	3	erosion	24
R205

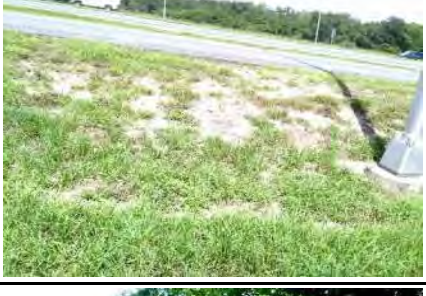
Roadway	Erosion	3	erosion	24
R206

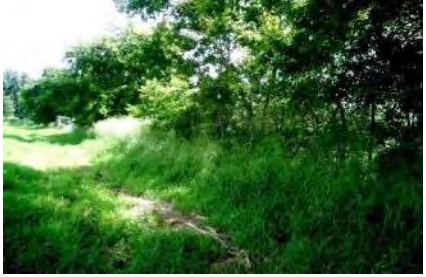
Roadway	Fence	3	overgrown vegetation on fence	24

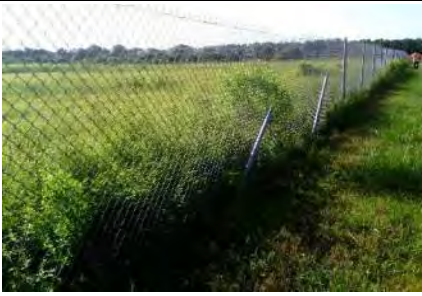
Roadway	Fence	3	fence post damaged	28
R208

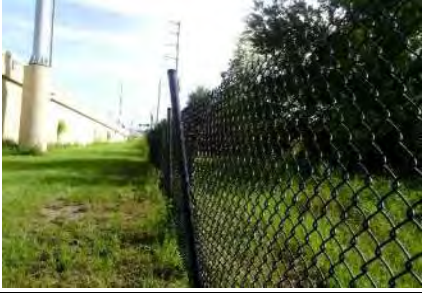
Roadway	Fence	3	fence posts damaged	31
R209

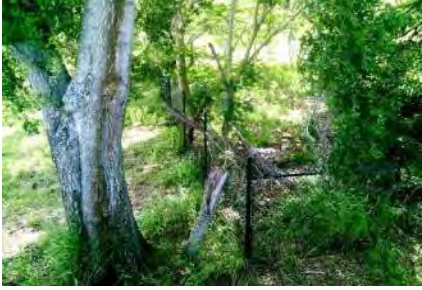
Roadway	Fence	3	fence damaged	36
R210

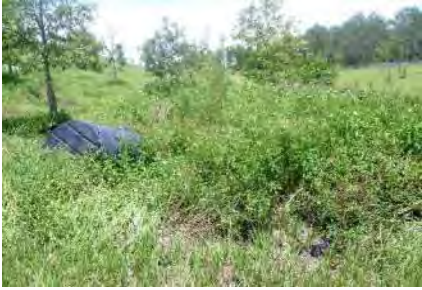
Roadway	Other	3	landscape debris	40
R211

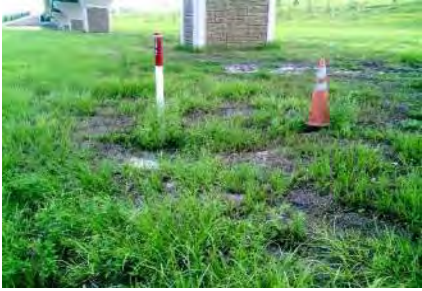
Roadway	Erosion	3	erosion	37
R212

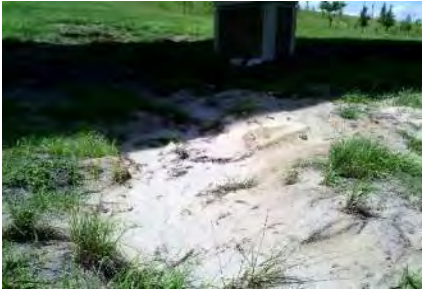
Roadway	Erosion	3	erosion	37

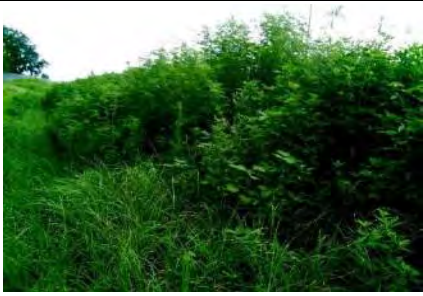
Roadway	Other	3	overgrown vegetation / not maintained	37
R214

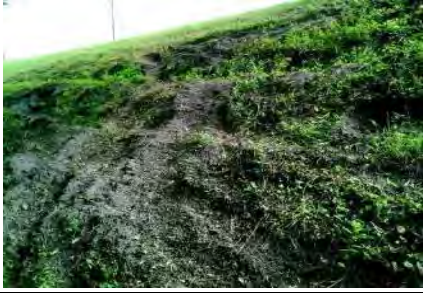
Roadway	Erosion	3	erosion	36
R215

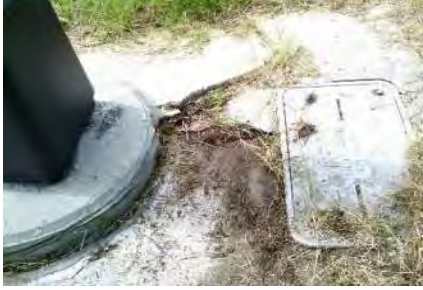
Roadway	Lighting	3	light pole base damaged / joint seal damaged	35
R216

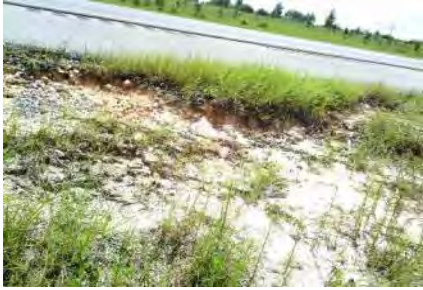
Roadway	Erosion	3	by paved shoulder	32
R217

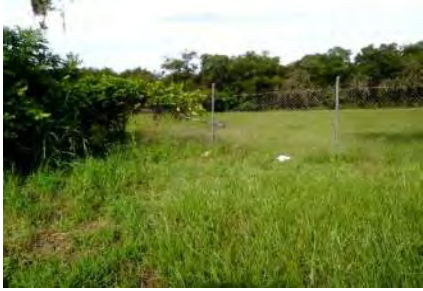
Roadway	Fence	3	fence damaged	24
R218

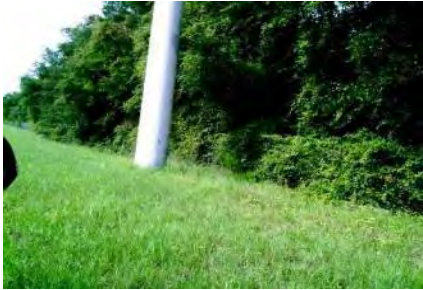
Roadway	Fence	3	vegetation overgrown all fence	23

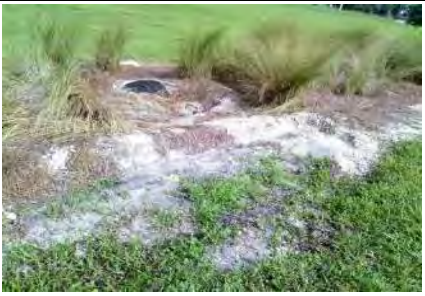
Roadway	Erosion	3	erosion by the shoulder	23
R220

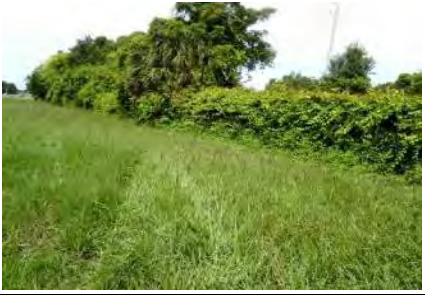
Roadway	Fence	3	heavy vegetation on fence	21
R221

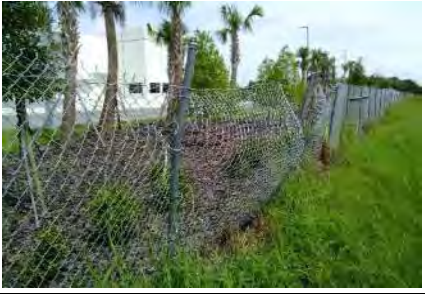
Roadway	Fence	3	fence damaged	19
WB1

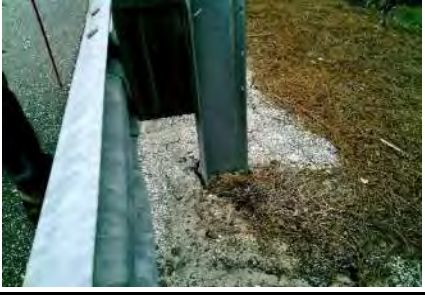
Walls or Barriers	Guardrail	1	asphalt cracked and comprised	15
WB2

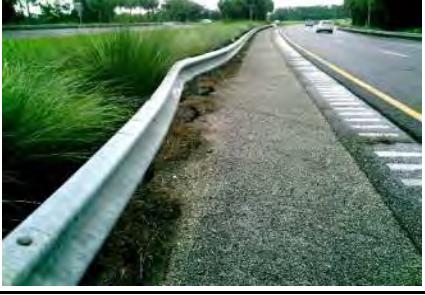
Walls or Barriers	Guardrail	1	guard rail smashed	15
WB3

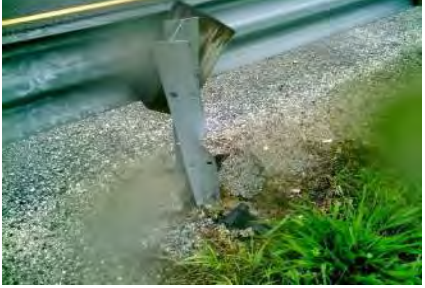
Walls or Barriers	Guardrail	1	pavement damaged at base/post damaged	20

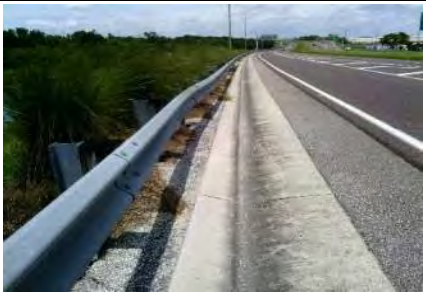
Walls or Barriers	Guardrail	1	guard rail hit	17
WB5	 	Walls or Barriers	Retaining Wall	2	slope pavement settled / damaged	3
WB6

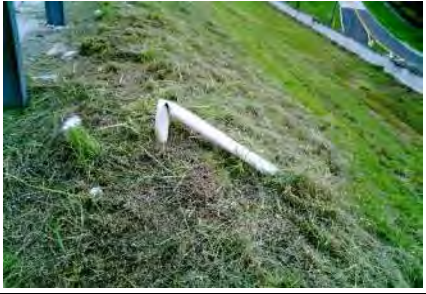
Walls or Barriers	Guardrail	2	delineator damaged	16
WB7

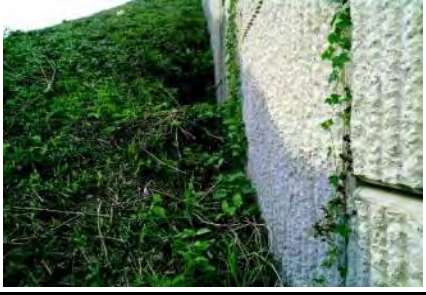
Walls or Barriers	Other	2	erosion along mse/vegetation	16
WB8	 	Walls or Barriers	Guardrail	2	asphalt cracked along flume top	15
WB9

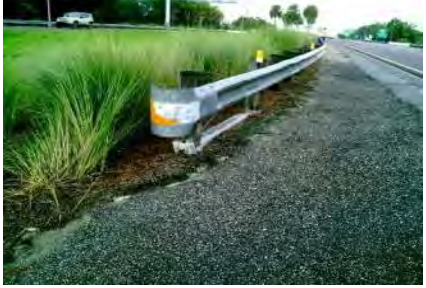
Walls or Barriers	Guardrail	2	light reflector damaged	15

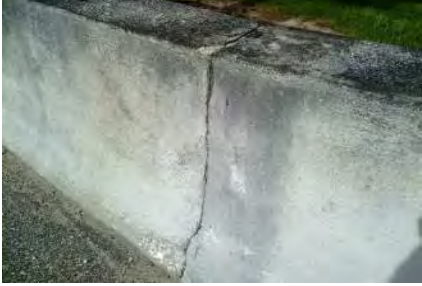
Walls or Barriers	Barrier Wall	2	several damaged spots along the entire section of wall	23

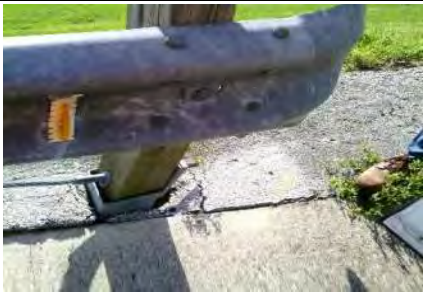
Walls or Barriers	Guardrail	3	mis asphalt around post damaged	6
WB17

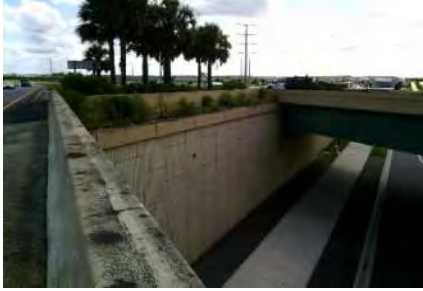
Walls or Barriers	Other	3	OVERGROWN VEGETATION	5
WB18

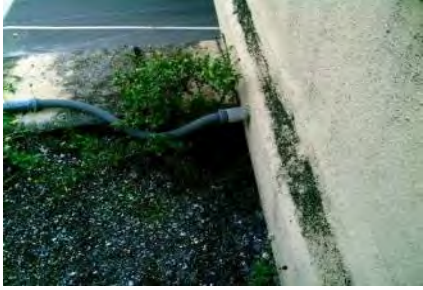
Walls or Barriers	Retaining Wall	3	slope pavement settled / open joint seal failure	3
WB19

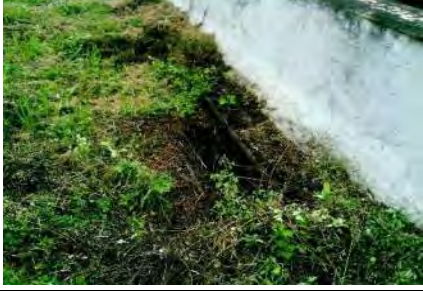
Walls or Barriers	Other	3	debris on gutter of mse / washing out	16
WB20

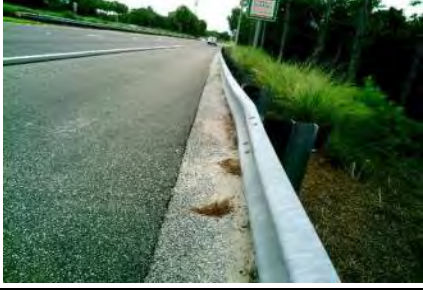
Walls or Barriers	Guardrail	3	dent	15
WB21

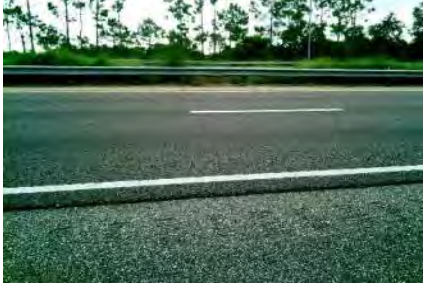
Walls or Barriers	Guardrail	3	dent	15

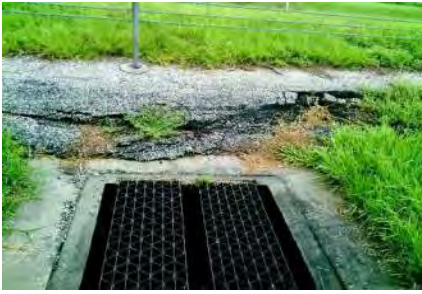
Walls or Barriers	Other	3	erosion around cable rail	22
WB35

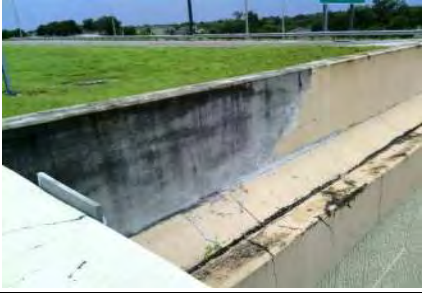
Walls or Barriers	Barrier Wall	3	finish coat missing	23
WB36

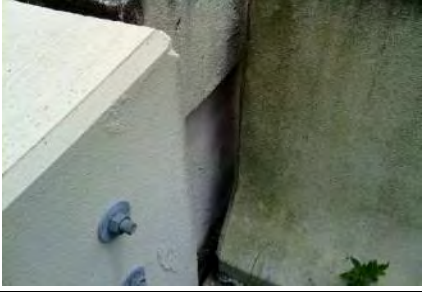
Walls or Barriers	Barrier Wall	3	open joint seal missing	23
WB37

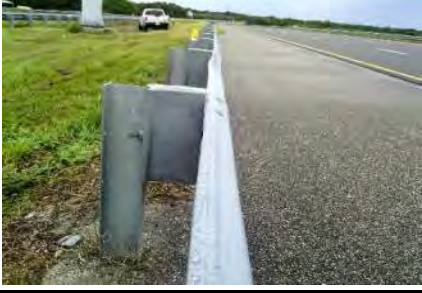
Walls or Barriers	Guardrail	3	bent	28
WB38

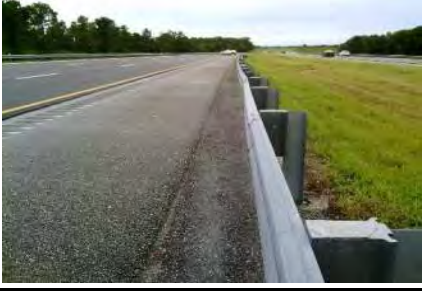
Walls or Barriers	Guardrail	3	bent	28
WB39

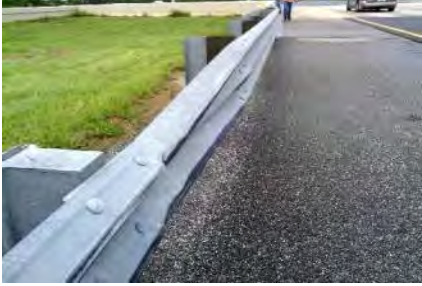
Walls or Barriers	Guardrail	3	bent	28

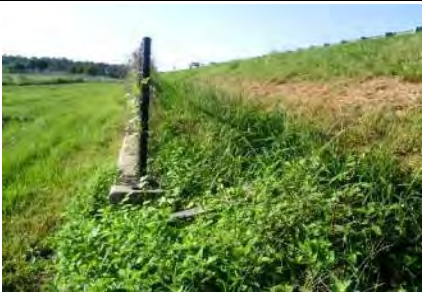
Walls or Barriers	Retaining Wall	3	vegetation overgrown on fence and mse wall coping gutter	28
WB47

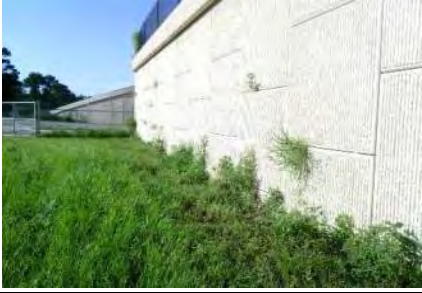
Walls or Barriers	Retaining Wall	3	vegetation overgrown mse wall	28
WB48

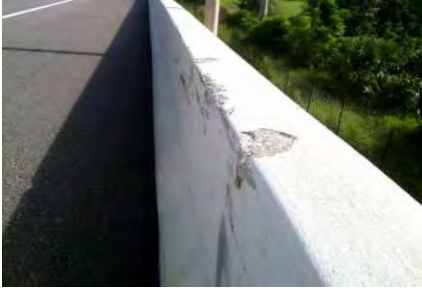
Walls or Barriers	Retaining Wall	3	mse wall coping gutter damaged	28
WB49

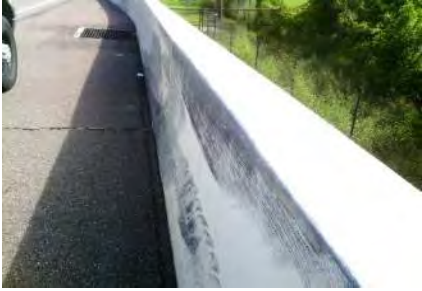
Walls or Barriers	Barrier Wall	3	Barrier wall hit	31
WB50

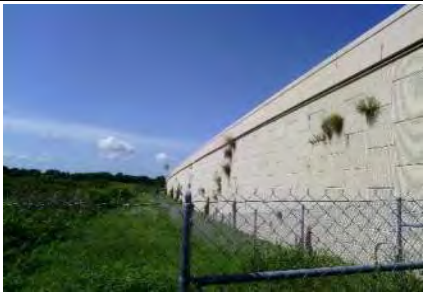
Walls or Barriers	Retaining Wall	3	overgrown vegetation	30
WB53

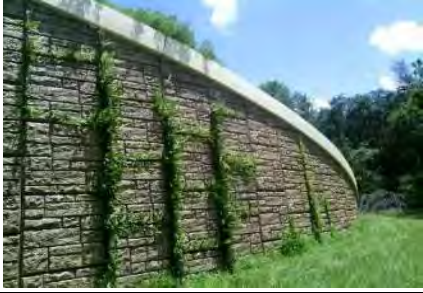
Walls or Barriers	Retaining Wall	3	overgrown vegetation	40
WB54

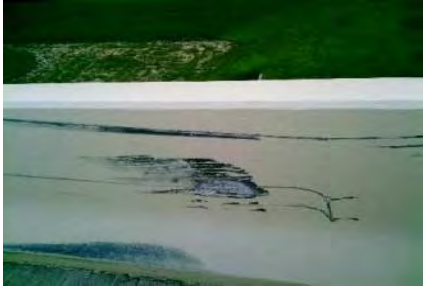
Walls or Barriers	Barrier Wall	3	barrier wall hit	40
WB55

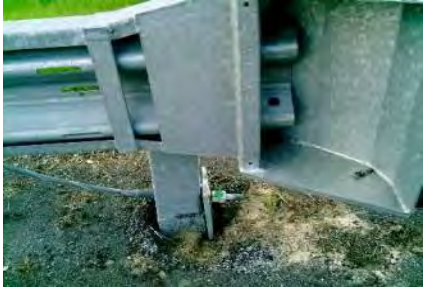
Walls or Barriers	Guardrail	3	miscellaneous asphalt damaged guardrail post	39
WB56

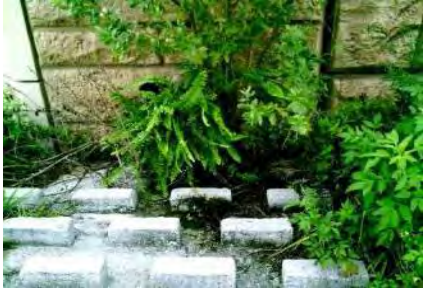
Walls or Barriers	Retaining Wall	3	MSE wall weep hole blocked	38
WB57

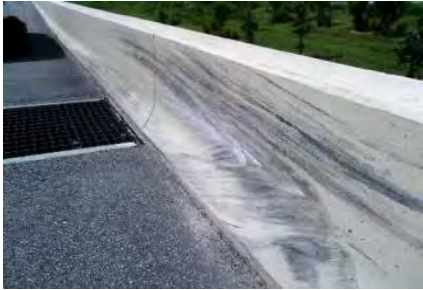
Walls or Barriers	Barrier Wall	3	barrier wall hit	32

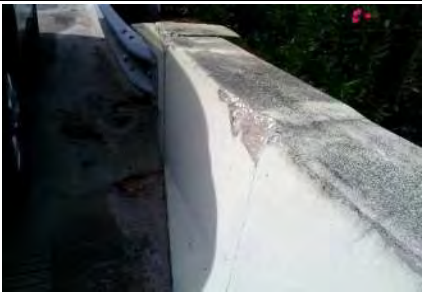
Walls or Barriers	Barrier Wall	3	barrier wall damaged	22
WB59

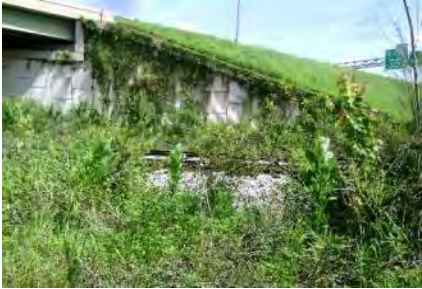
Walls or Barriers	Retaining Wall	3	vegetation overgrown mse wall	18

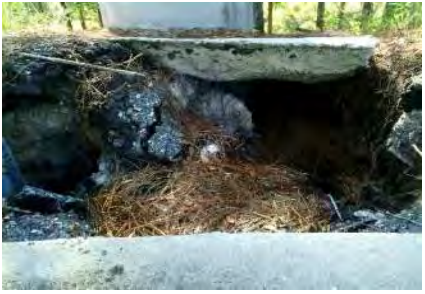
Roadside	Erosion	1	washout light post foundation	5
1

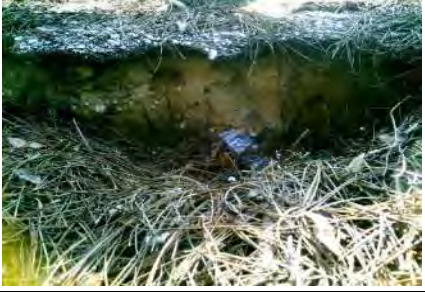
Roadside	Erosion	2	exposed base	5
3

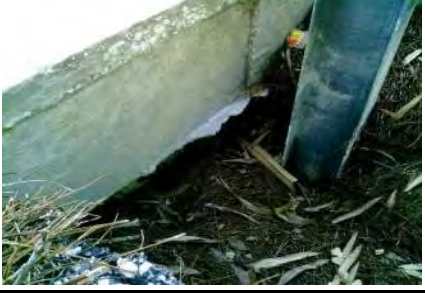
Roadside	Erosion	1	exposed approach slab	5
4

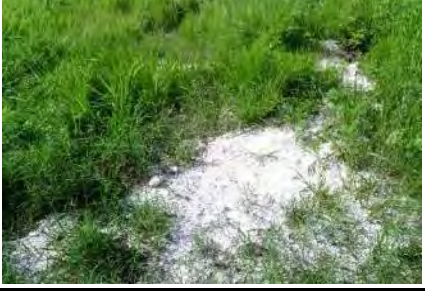
Roadside	Erosion	2	clogged ditch	4
5

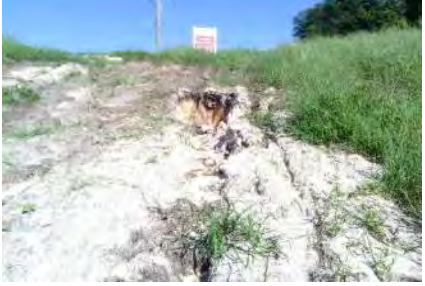
Roadside	Erosion	2	erosion	4

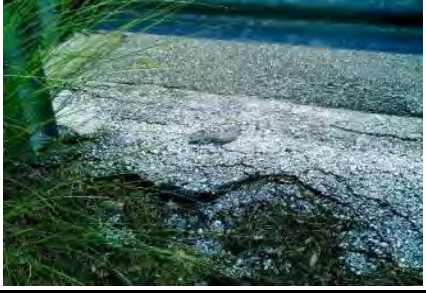
Roadside	Erosion	3	erosion undermining the miscellaneous asphalt	5
10

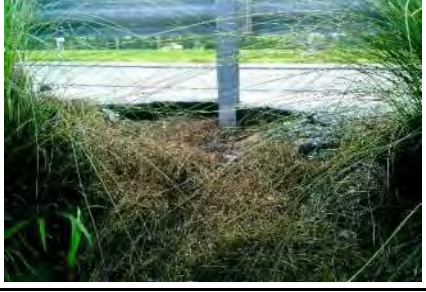
Roadside	Erosion	2	erosion undermining the miscellaneous asphalt	5
11

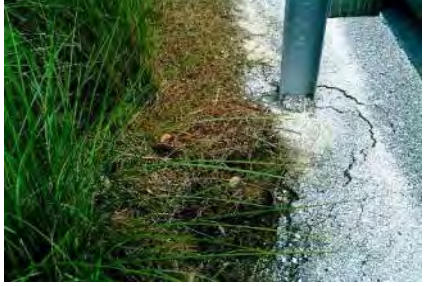
Roadside	Erosion	3	erosion undermining the miscellaneous asphalt	5

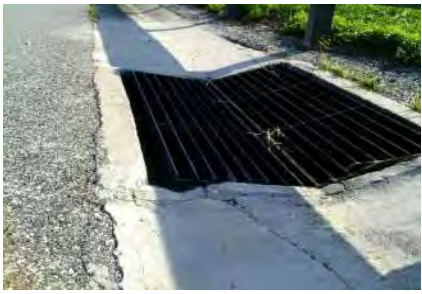
Drainage	Drainage Structure	1	damaged and silted	3
13
