2020

Annual Inspection Report

Appendix 3: SR 408

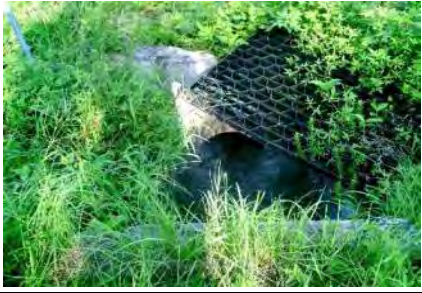
Drainage	Drainage Structure	1	broken inlet missing grate	4
14

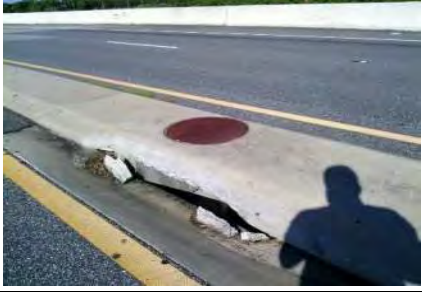
Drainage	Drainage Structure	2	broken inlet	5
15

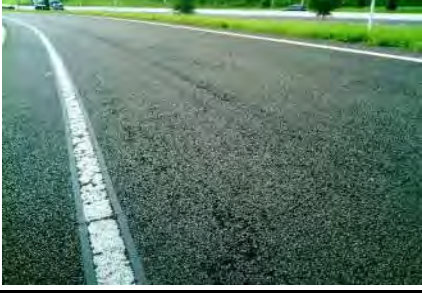
Pavement	Cracking	2	cracked	3
16

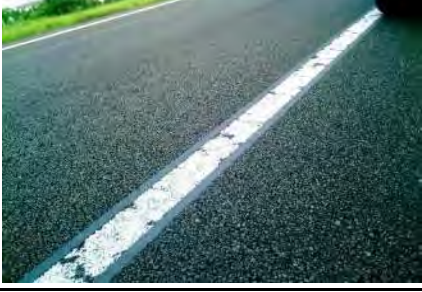
Pavement	Striping or Pavement Marking	2	faded poor condition	3
17

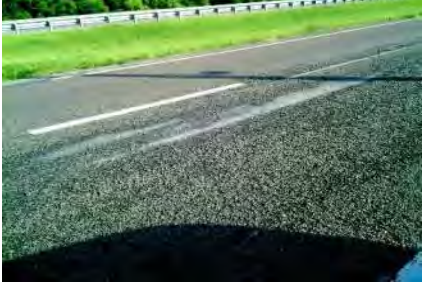
Pavement	Cracking	2	cracked breaking	3

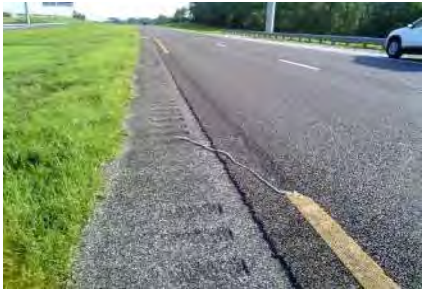
Pavement	Striping or Pavement Marking	2	missing	3
19

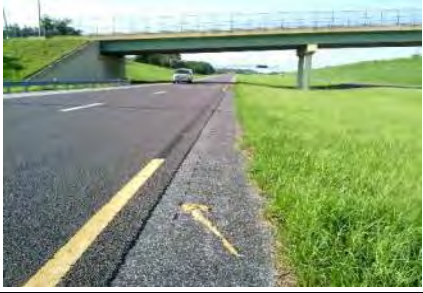
Pavement	Striping or Pavement Marking	2	missing	4
20

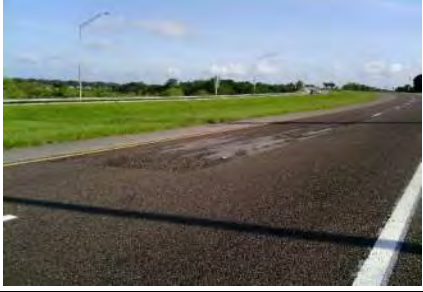
Pavement	Pothole	2	rutting	4
21

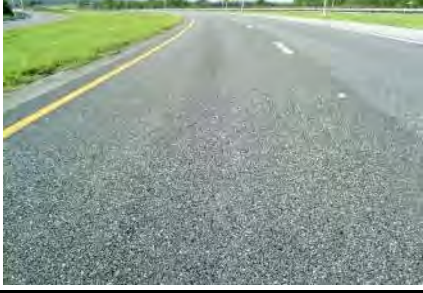
Pavement	Cracking	2	rutting	5
22

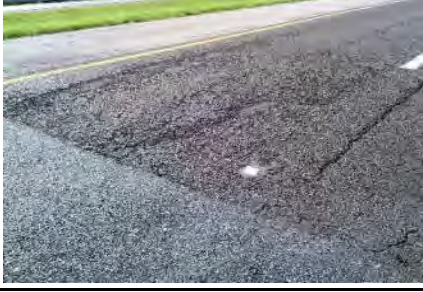
Pavement	Cracking	2	rutting	4
23

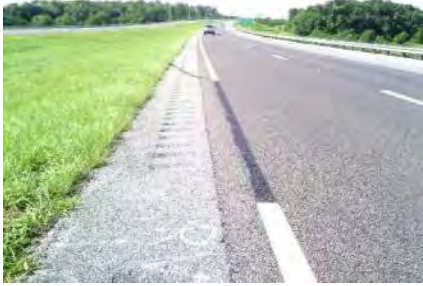
Pavement	Striping or Pavement Marking	2	missing	4

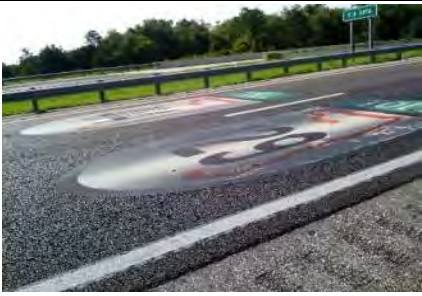
Pavement	Striping or Pavement Marking	2	peeling	3
25	 	Pavement	Cracking	2	rutting	3
26	 	Pavement	Cracking	3	cracked	1
27	 	Pavement	Edge Ravel	3	asphalt damaged	1
28	 	Walls or Barriers	Guardrail	2	hit posts moved	5
29	 	Walls or Barriers	Guardrail	3	fairly damaged	2

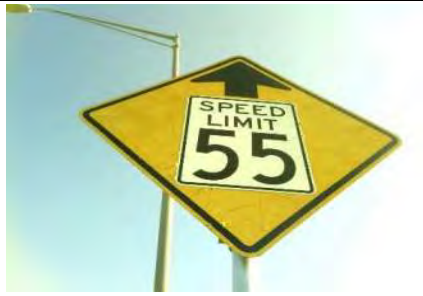
Other Issue	Other	3	cracking sign	4
31

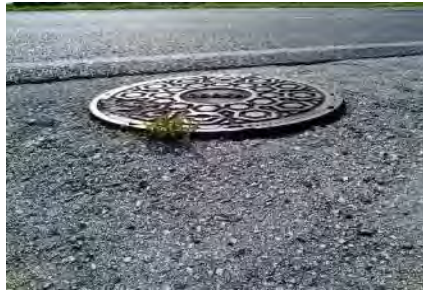
Other Issue	Other	3	manhole not flush	4

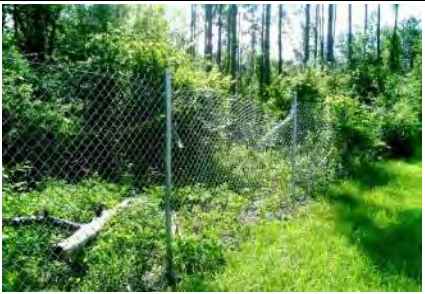
Roadside	Fence	1	fence damaged	3
1

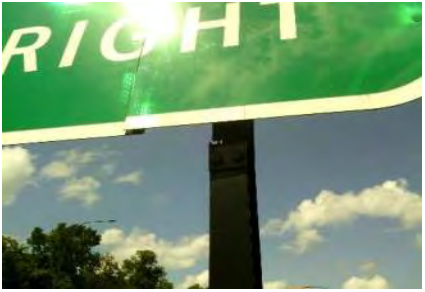
Roadside	Other	2	sign broken	4
2

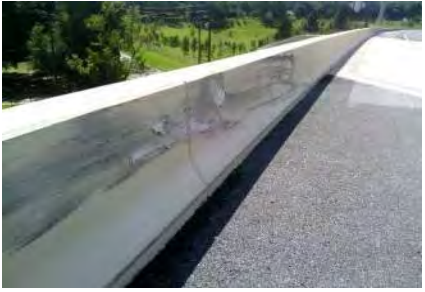
Walls or Barriers	Barrier Wall	3	finish coat peeling	4
3

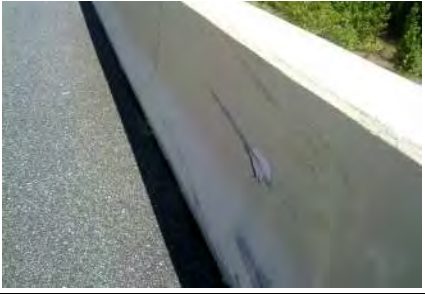
Walls or Barriers	Barrier Wall	3	finish coat peeling	4
4

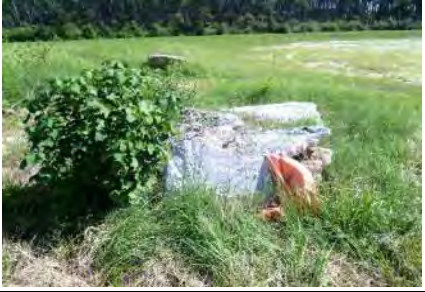
Other Issue	Other	3	construction debris	1
5

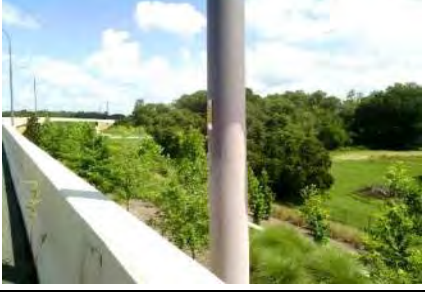
Other Issue	Other	3	overspray on light poles all along the bridge	4

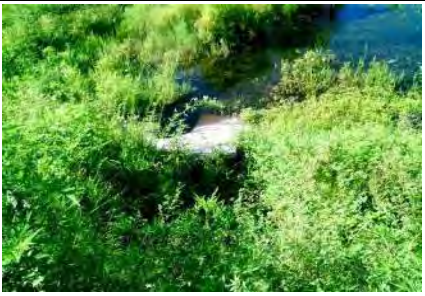
Drainage	Drainage Structure	2	erosion around the mes	1
1

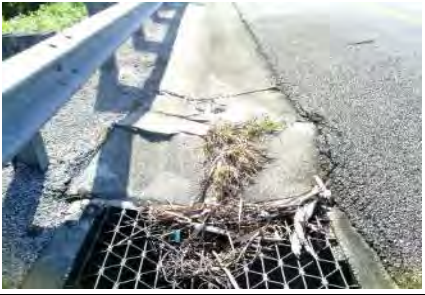
Drainage	Other	2	shoulder gutter severely damaged	6
2

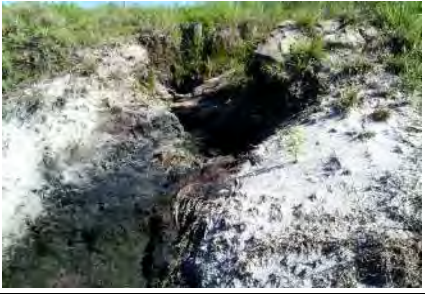
Drainage	Pond/ Ditch/ Canal	1	wet pond thats dried out / heavy erosion around the pond / drainage structures severely damaged	11
3

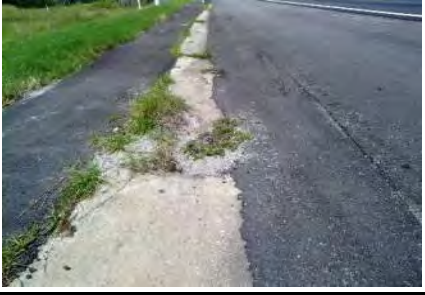
Drainage	Other	3	shoulder gutter damaged	18
4

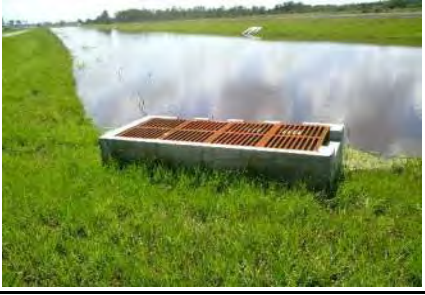
Drainage	Drainage Structure	3	control structure skimmer missing	24
5

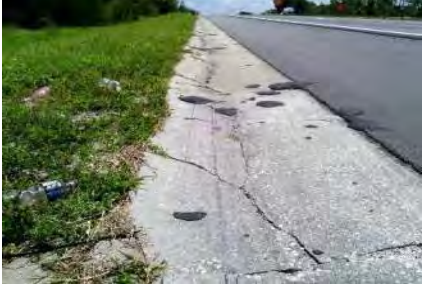
Drainage	Other	3	shoulder gutter damaged	18

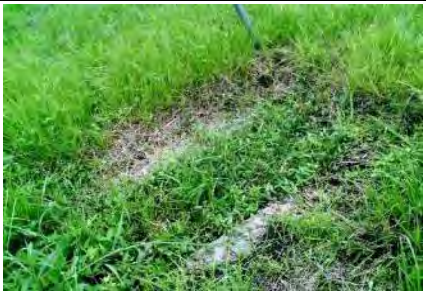
Drainage	Drainage Structure	3	u type endwall obstructed / not maintained	17
7

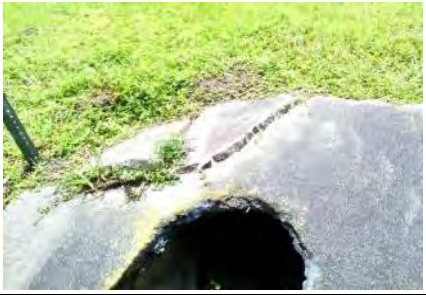
Drainage	Drainage Structure	2	mes severely damaged	10
8	 	Drainage	Drainage Structure	3	dbi damaged / grate not secured	9
9

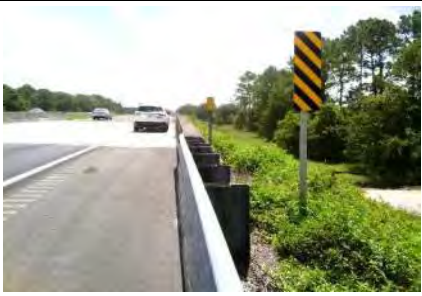
Other Issue		3	incorrect sign	27
13

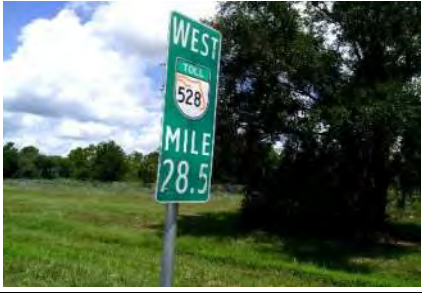
Other Issue		3	mile marker damaged	28
14

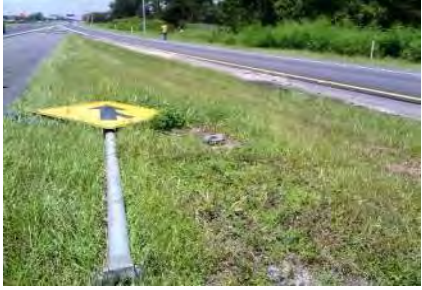
Other Issue		1	sign down	21
15

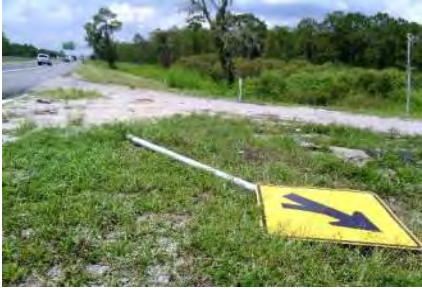
Other Issue		2	sign down	18
16

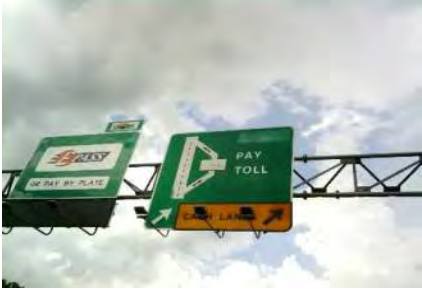
Other Issue		3	sign panel finish peeling	13
17

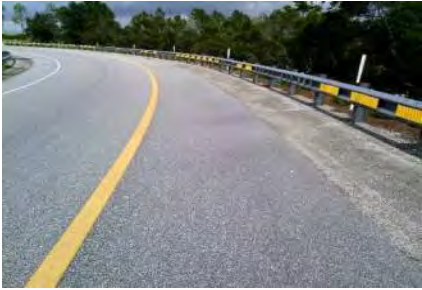
Other Issue			delineators damaged / missing	6

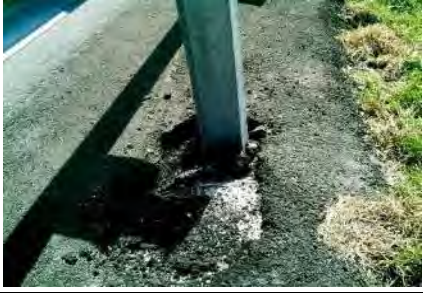
Pavement	Other	3	miscellaneous asphalt damaged	19
20

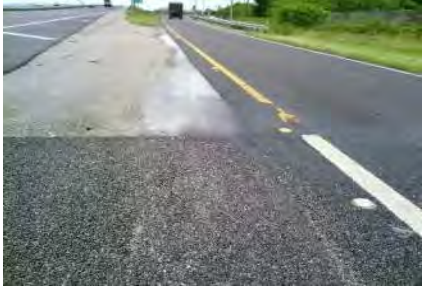
Pavement	Other	2	water ponding	8
21

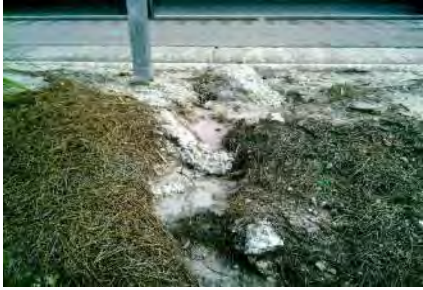
Roadside	Erosion	3	erosion by the shoulder / broken shoulder gutter	2
22

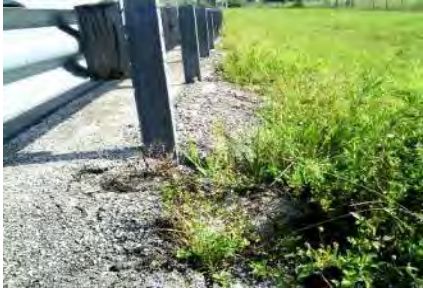
Roadside	Erosion	3	erosion by the shoulder / undermining miscellaneous asphalt	-
23

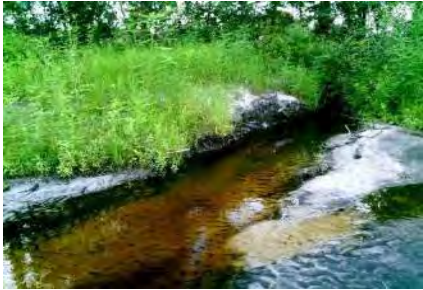
Roadside	Erosion	3	erosion	29

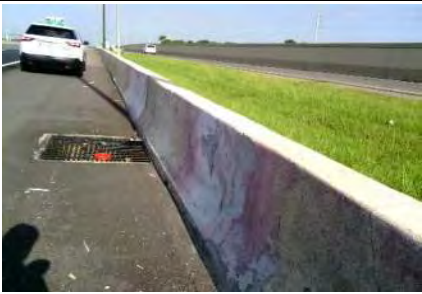
Walls or Barriers	Barrier Wall	3	barrier wall damaged	1
25

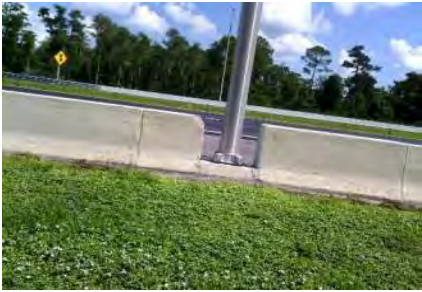
Walls or Barriers	Barrier Wall	3	barrier wall damaged	24
26

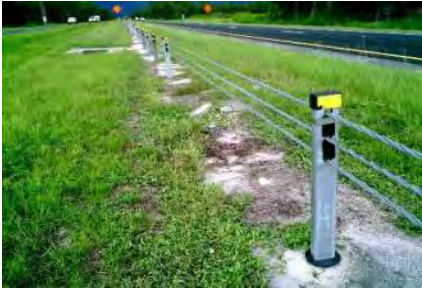
Walls or Barriers	Other	2	cable rail post missing	28
27

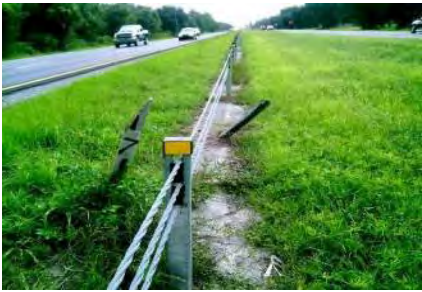
Walls or Barriers	Other	2	cable rail post damaged at two spots	28
28

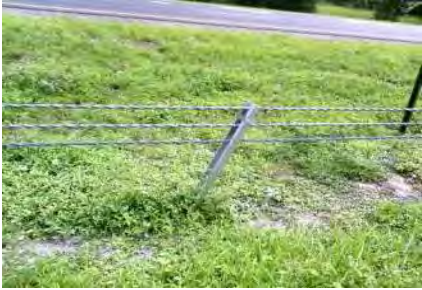
Walls or Barriers	Other	3	cable rail post damaged	21
29

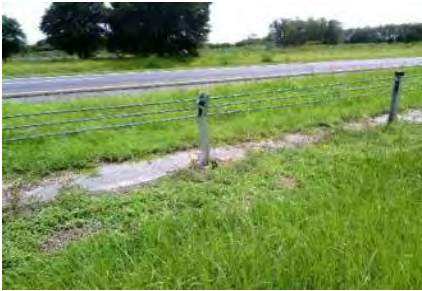
Walls or Barriers	Other	3	cable rail post damaged	18

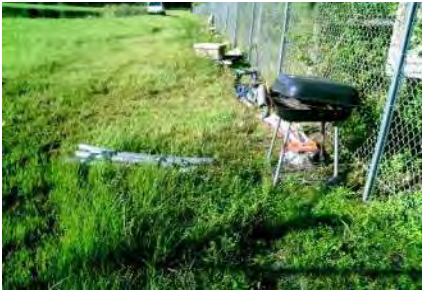
Drainage	Pond/ Ditch/ Canal	3	debris around the pond	3
1

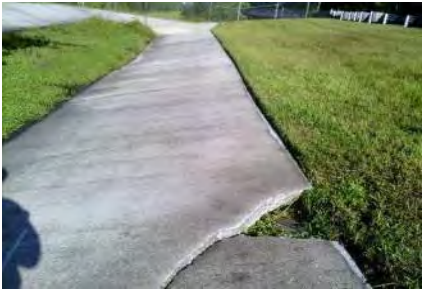
Drainage	Pond/ Ditch/ Canal	3	concrete ditch damaged	5
2

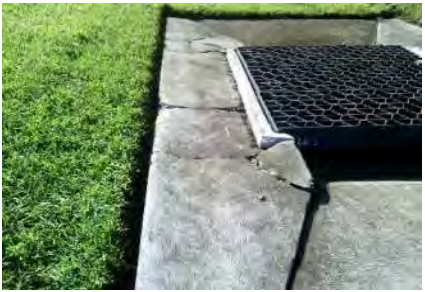
Drainage	Drainage Structure	3	dbi damaged	5
3

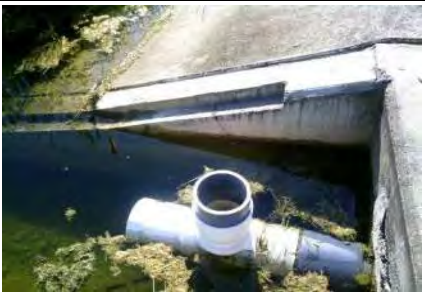
Drainage	Drainage Structure	2	cap missing for orifice	5
4

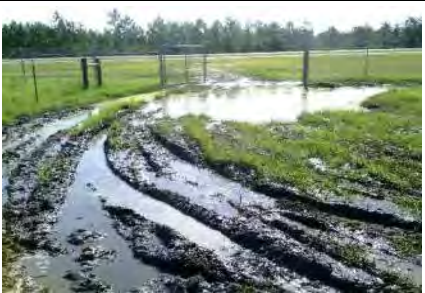
Drainage	Pond/ Ditch/ Canal	2	erosion and water ponding at entrance of pond	7
5

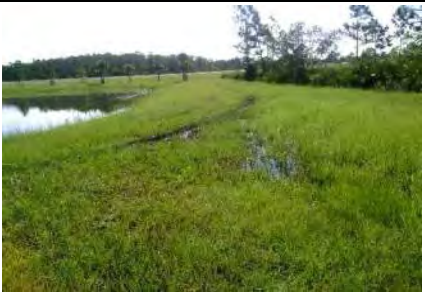
Drainage	Other	2	berm for the pond overrun by pond water	7

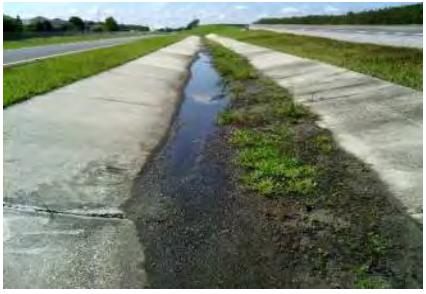
Drainage	Pond/ Ditch/ Canal	3	sediment in ditch	11
7

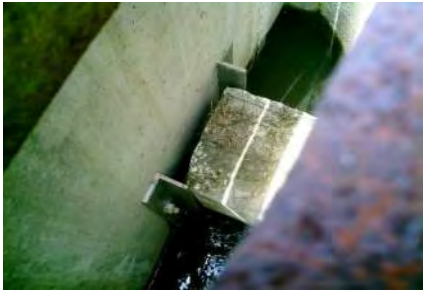
Drainage	Drainage Structure	3	bleeder orifice in L bracket	8
8

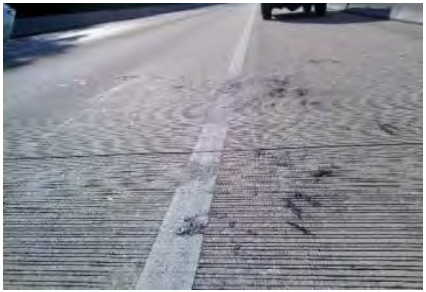
Pavement	Striping or Pavement Marking	2	faded centerline and edge striping	3
9

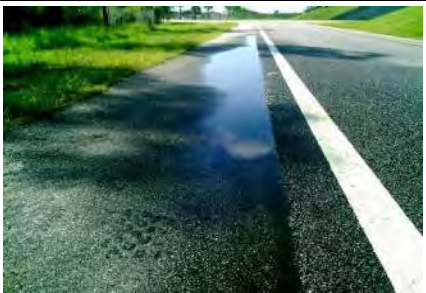
Pavement	Other	3	water ponding on paved shoulder	8
10

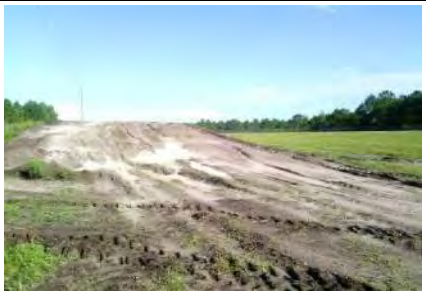
Roadway	Erosion	3	embankment not graded / vegetation missing	3
11

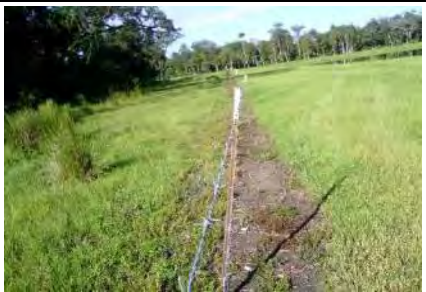
Roadway	Fence	3	fence damaged - leaning / gate in row	5

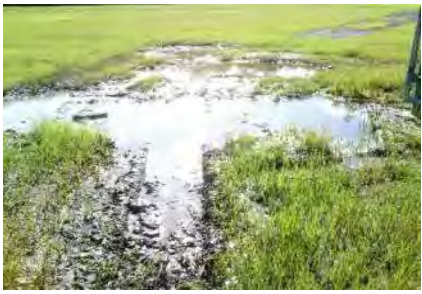
Roadway	Erosion	2	erosion / water ponding	6
13

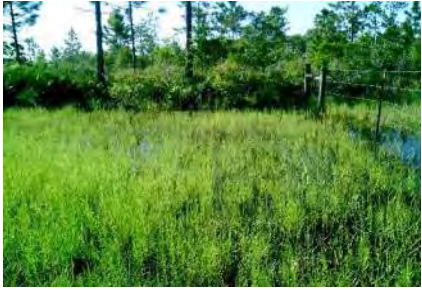
Roadway	Fence	1	fence around the pond missing / down	7
14

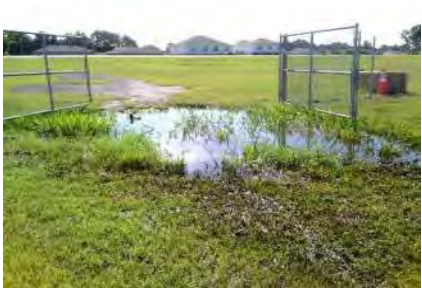
Roadway	Erosion	2	puddle at gate entrance caused by erosion (all ponds along 538)	9
15

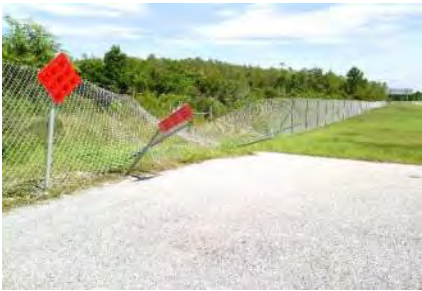
Roadway	Fence	2	fence damaged	11
16

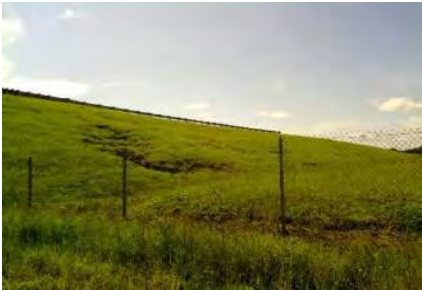
Roadway	Erosion	2	slope erosion	11
17

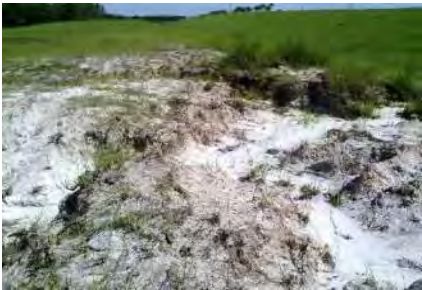
Roadway	Erosion	2	erosion	11

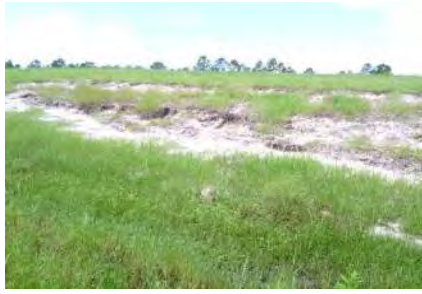
Roadway	Erosion	2	slope erosion at several spots	8
19

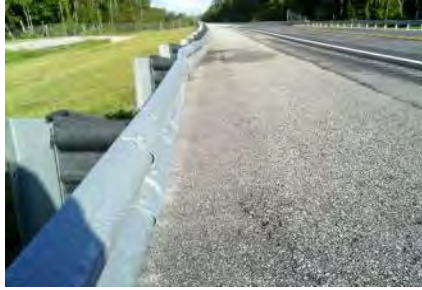
Walls or Barriers	Guardrail	2	guardrail smashed	5
20

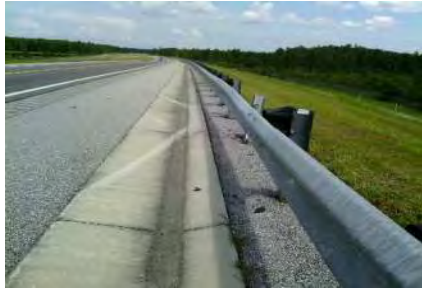
Walls or Barriers	Guardrail	1	guard rail smashed	8
21

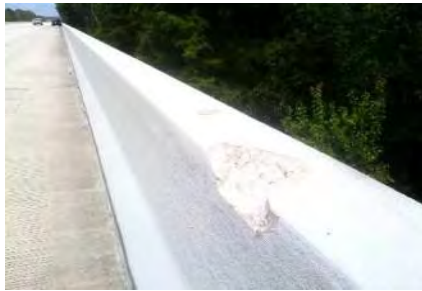
Walls or Barriers	Barrier Wall	3	barrier wall damaged	4
